Water Intrusion in Central Florida Homes During Hurricane Jeanne in September 2004

Prepared by:
Dr. Mike Mullens, PE
Dr. Bob Hoekstra
Isabelina Nahmens
Felix Martinez

UCF Housing Constructability Lab

August 2006

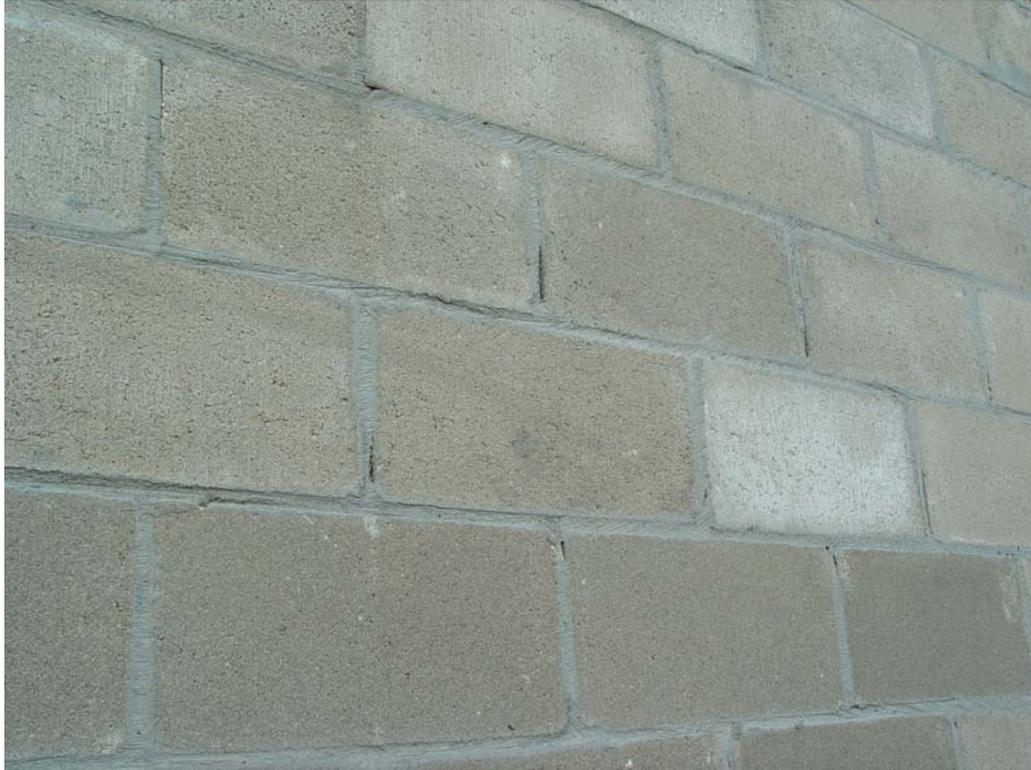
Figure 15 Varying workmanship of mortar joints

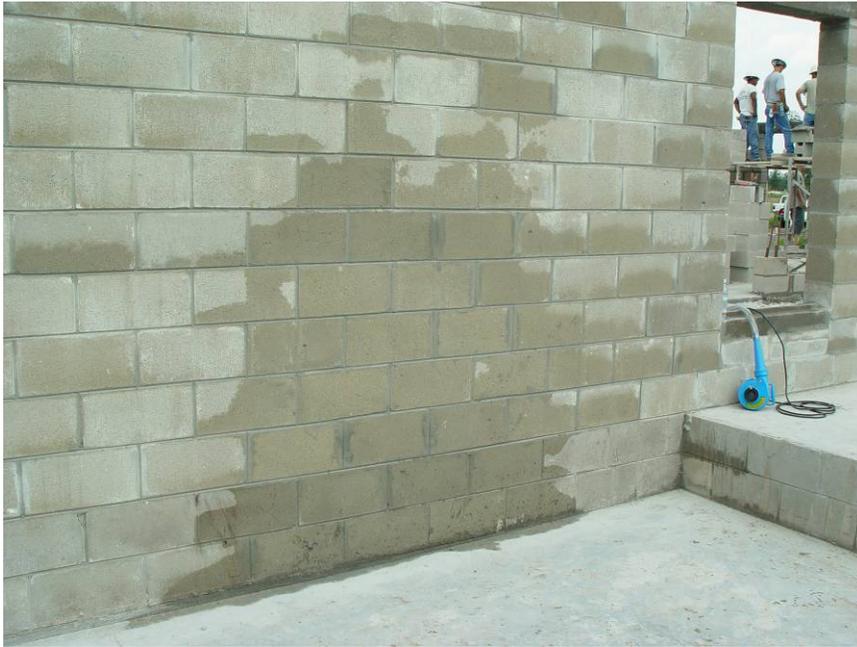
Figure 16 Dampness on inside of wall during test

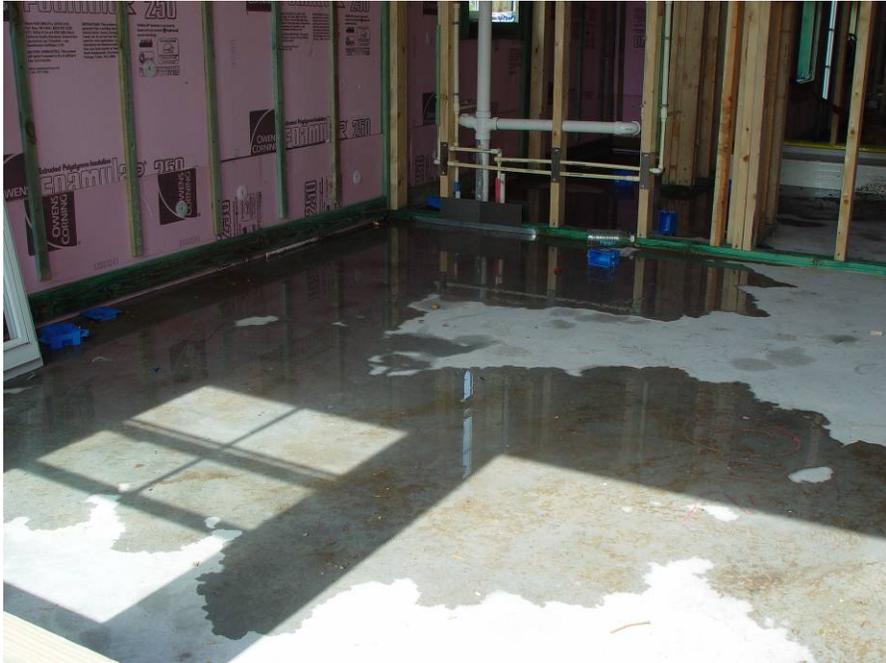
Figure 17 Standing water on floor during test

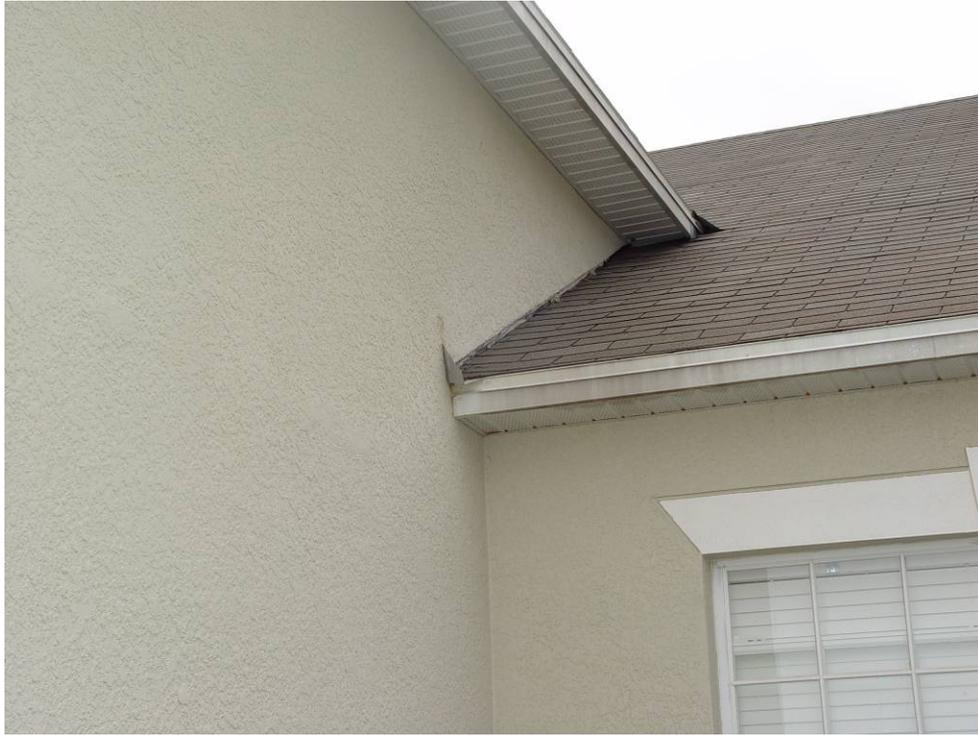
Figure 18 Stucco cracking and damage around flashing

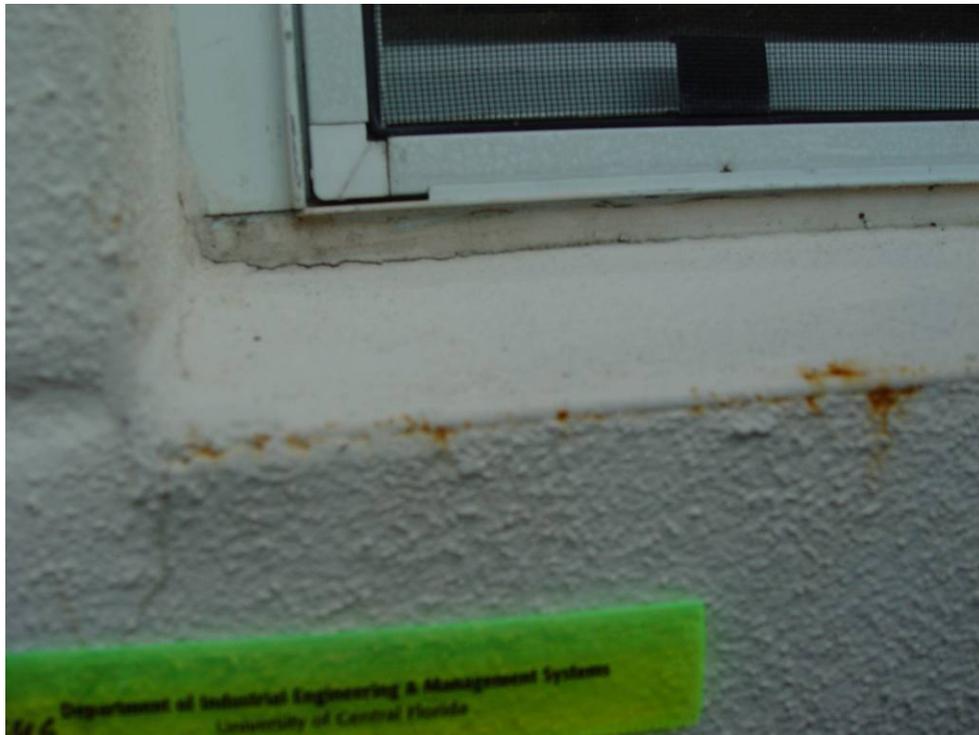
Figure 19 Cracks in window caulking

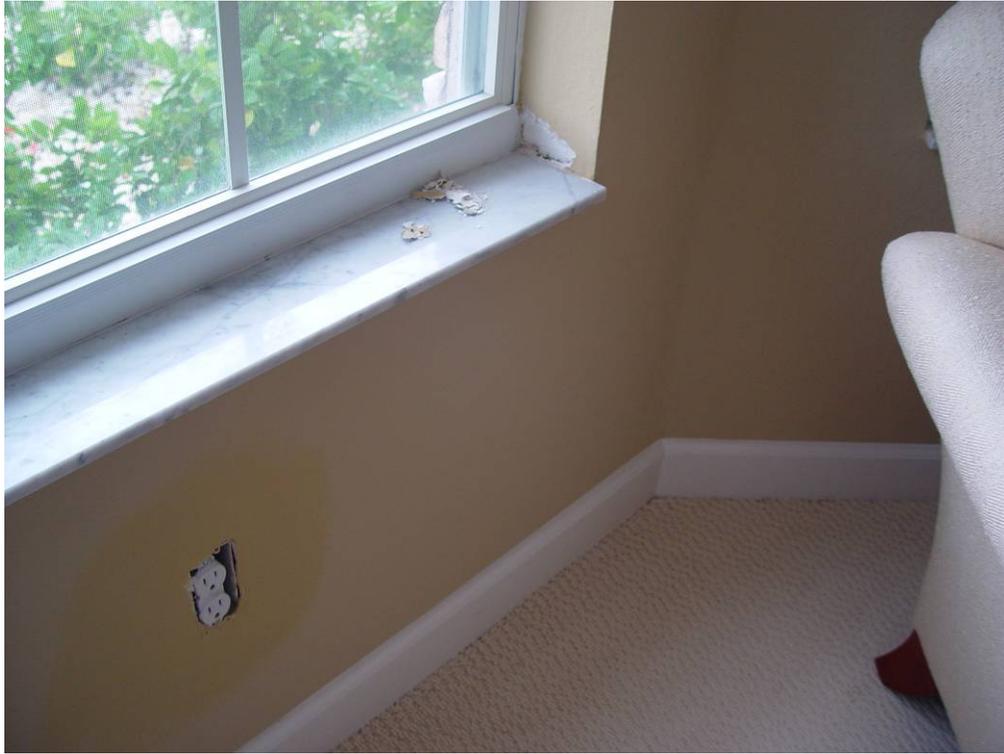
Figure 20 Water damage around and under window

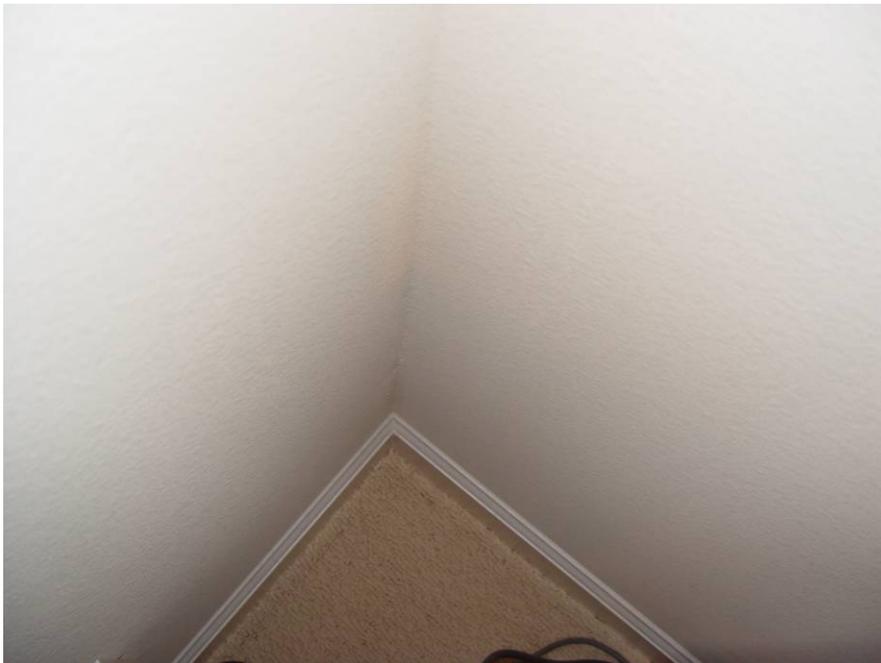
Figure 21 Water damage in corner

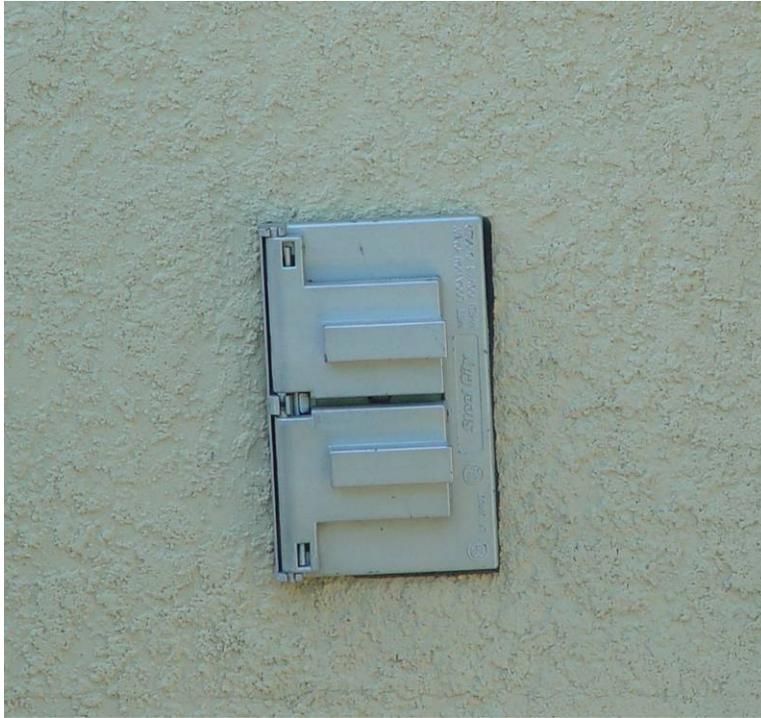
Figure 22 Unsealed penetration for electrical outlet

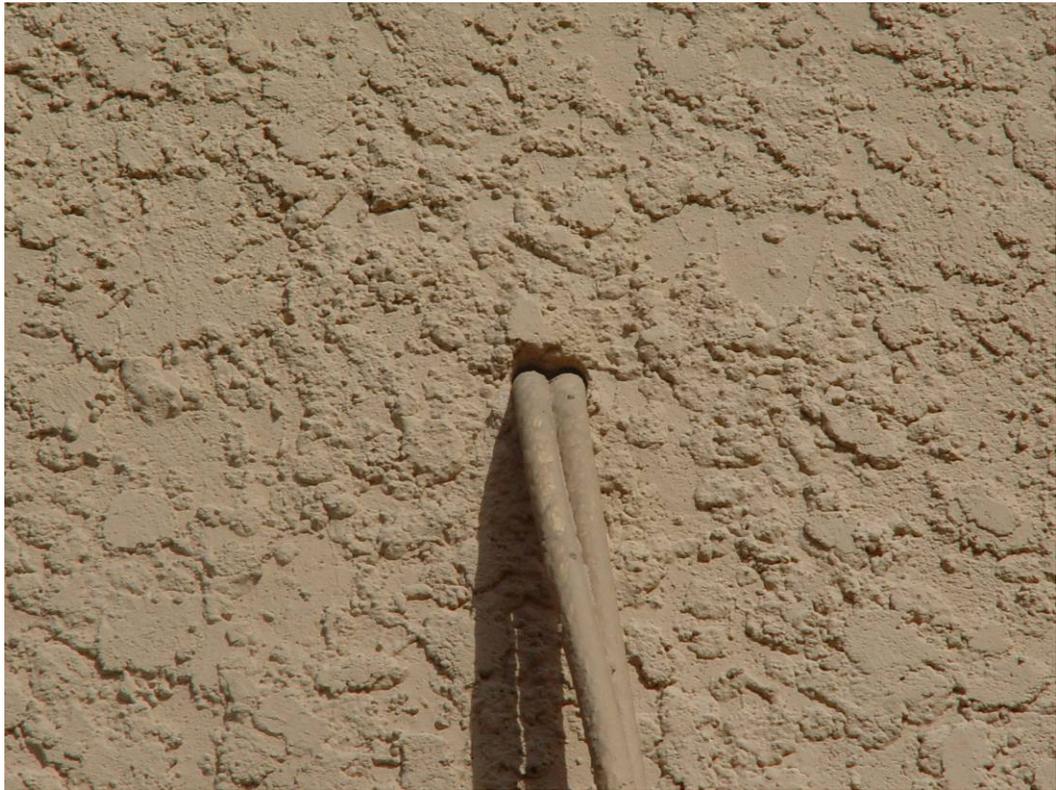
Figure 23 Unsealed penetration for wiring

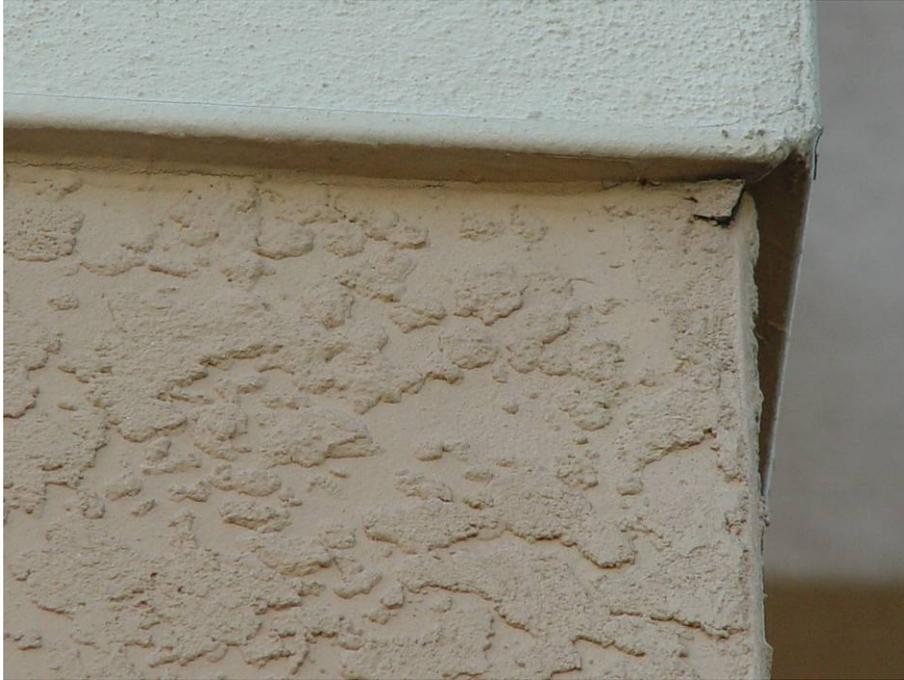
Figure 24 Crack at 1st/2nd floor expansion joint from poor workmanship

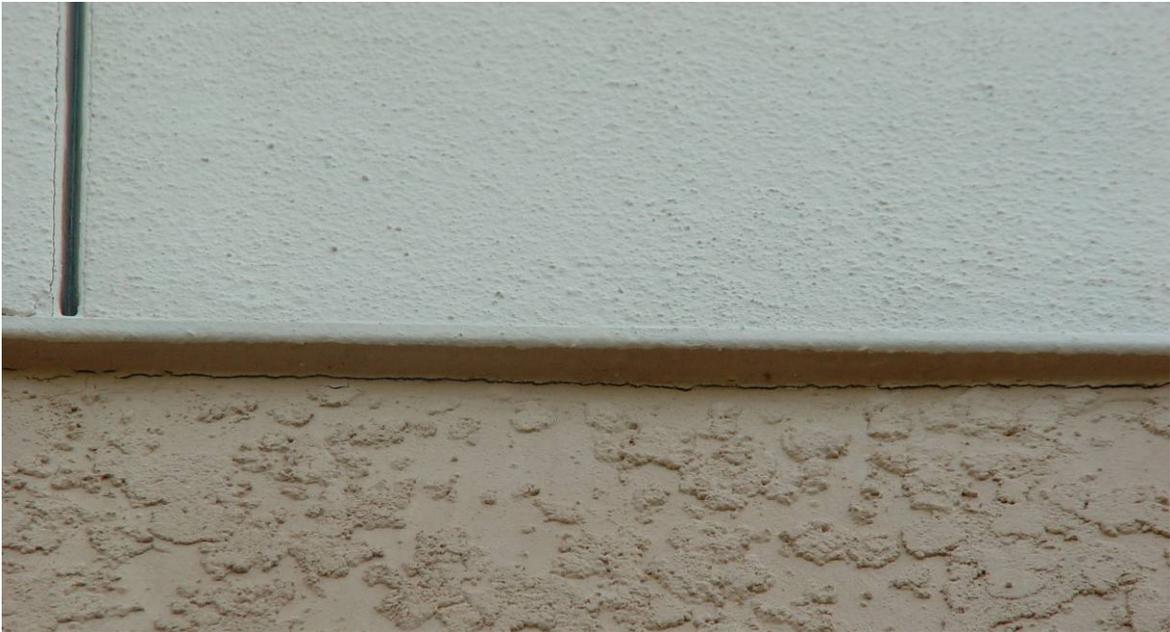
Figure 25 Crack at 1st/2nd floor expansion joint

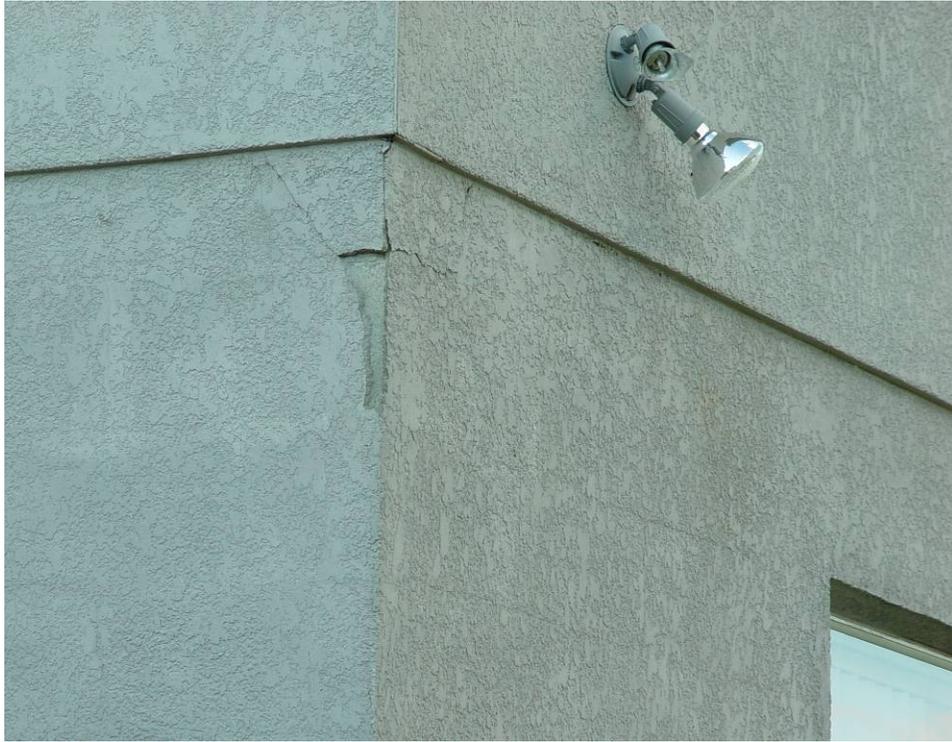
Figure 26 Stucco damage on corner

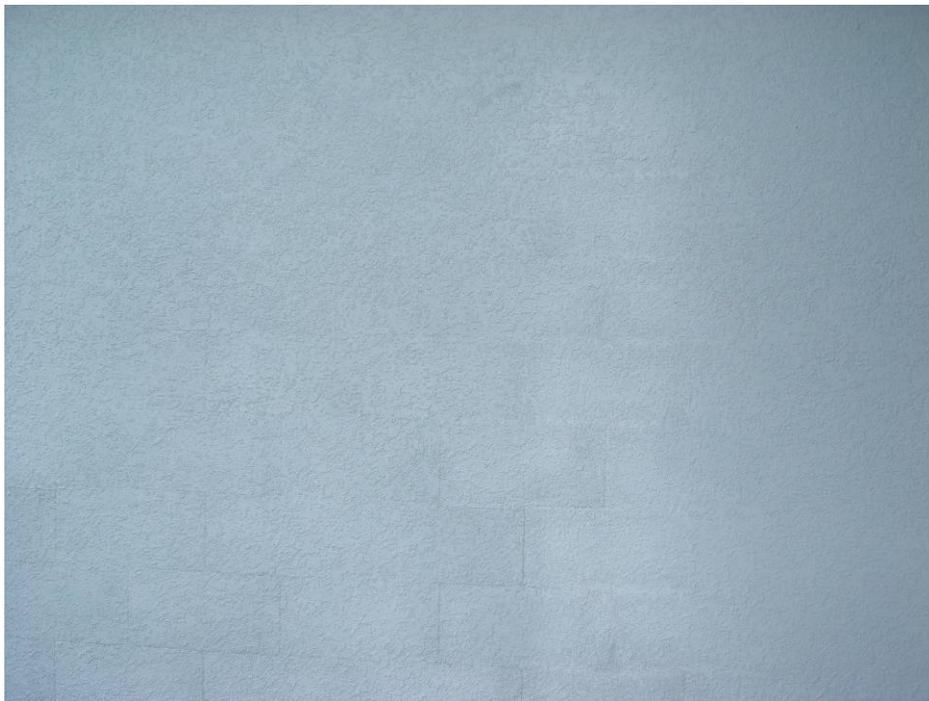
Figure 27 Stucco telegraphing

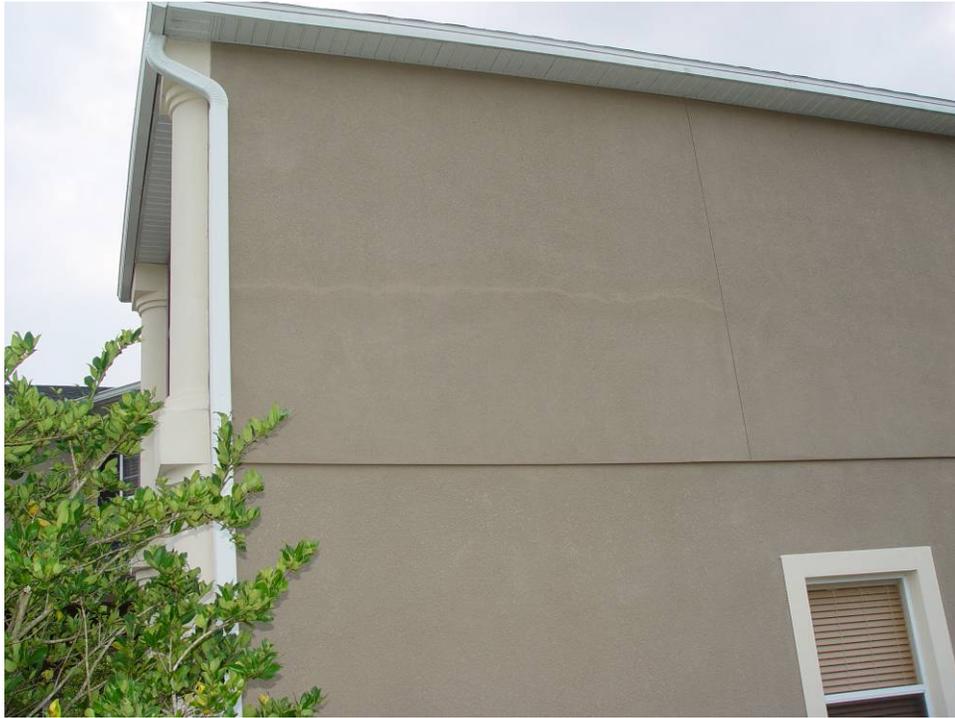
Figure 28 Repaired horizontal crack on 2nd floor frame wall

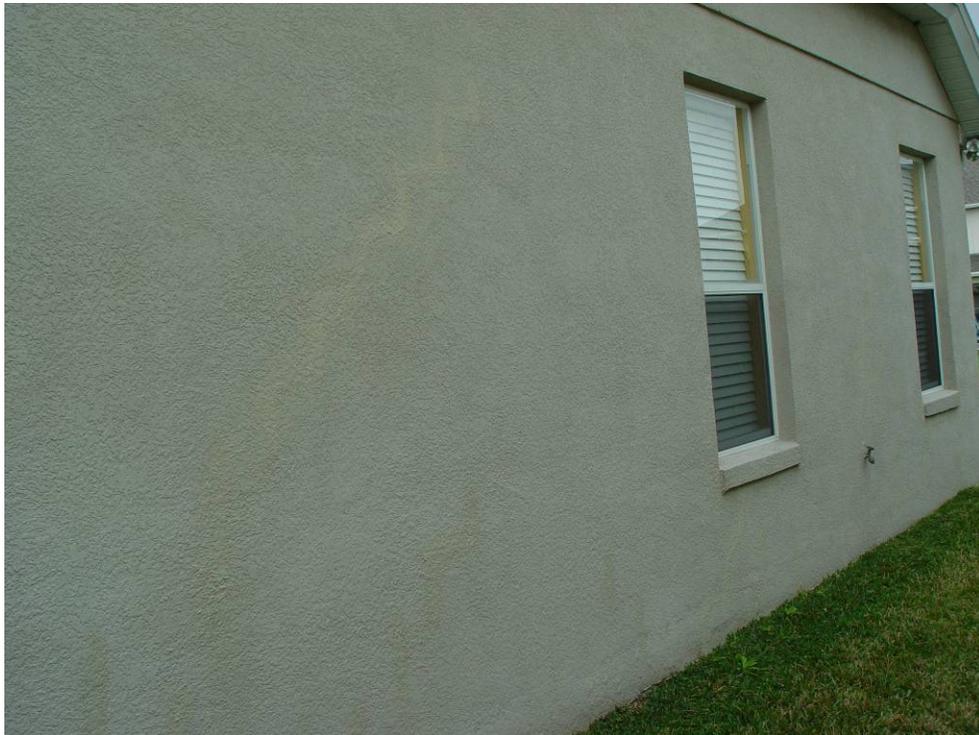
Figure 29 Patch of stairstep crack using elastomeric compound

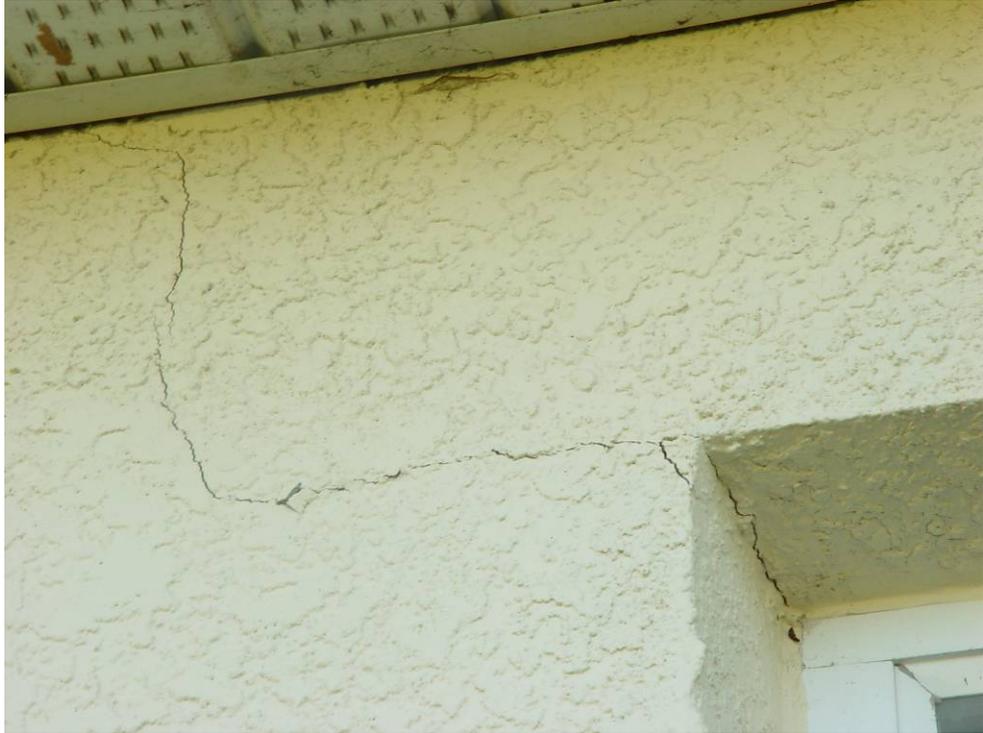
Figure 30 Window corner crack

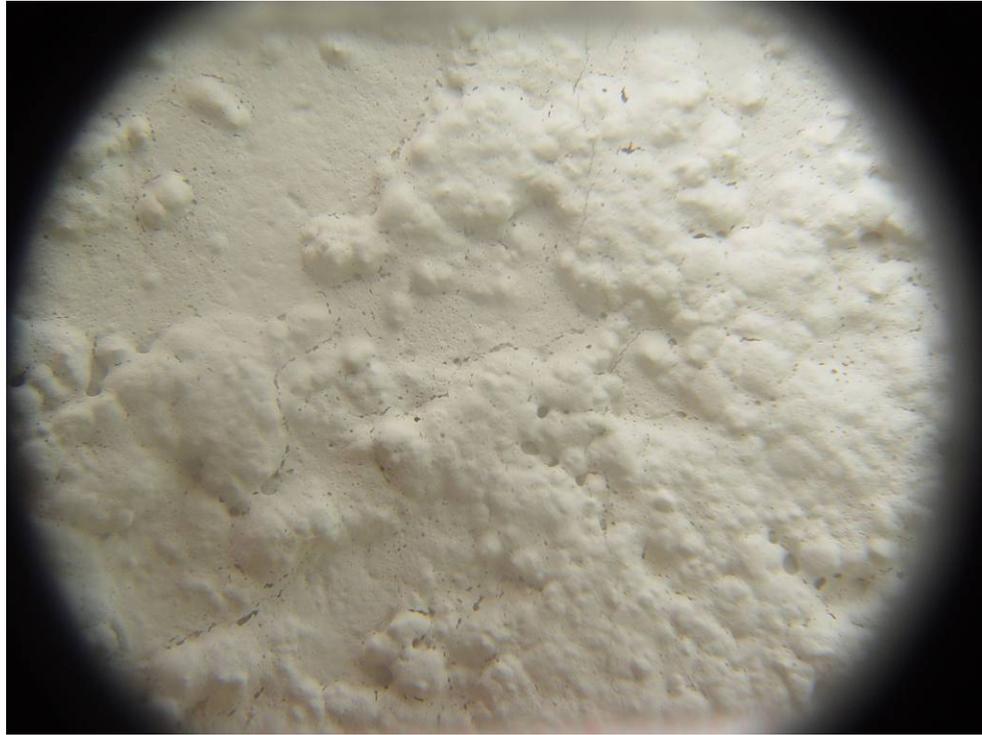
Figure 31 Tiny micro-cracks in stucco seen through 5X jeweler's loop

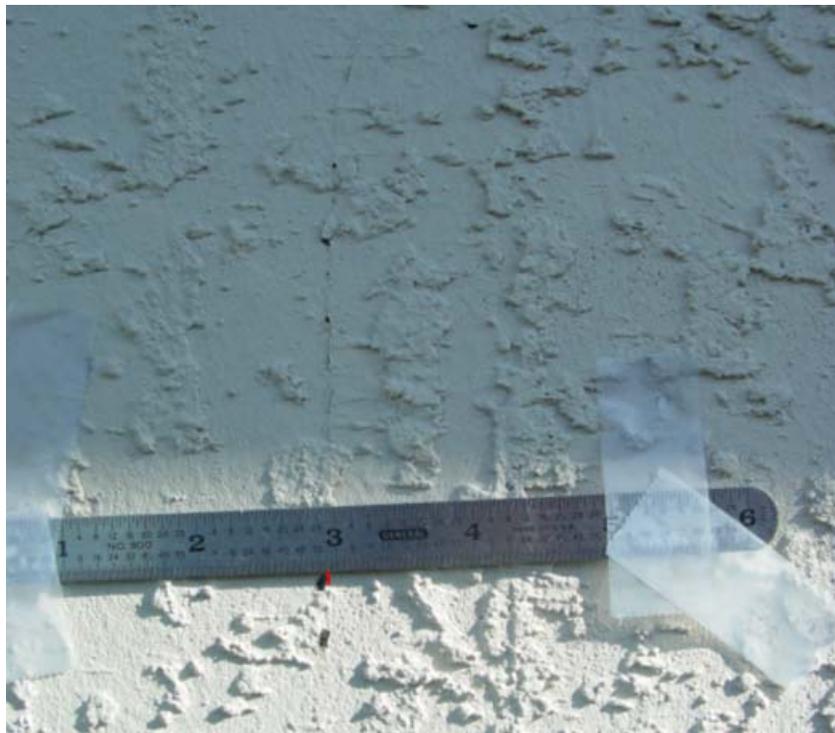
Figure 32 The smallest crack measured - 0.13mm wide

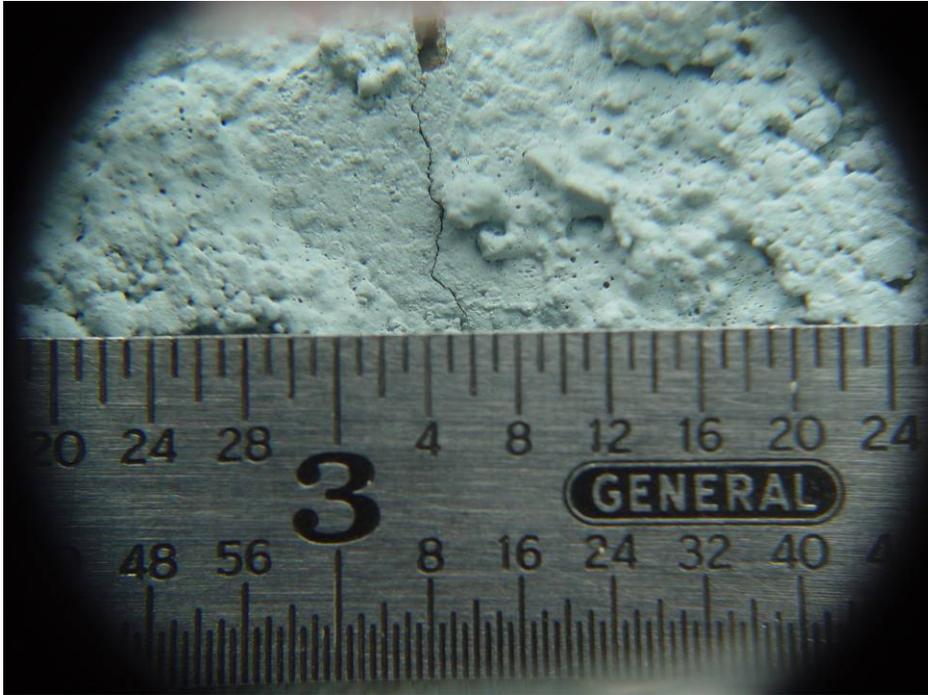
Figure 33 Typical crack less than 0.39 mm (1/64 inch) wide

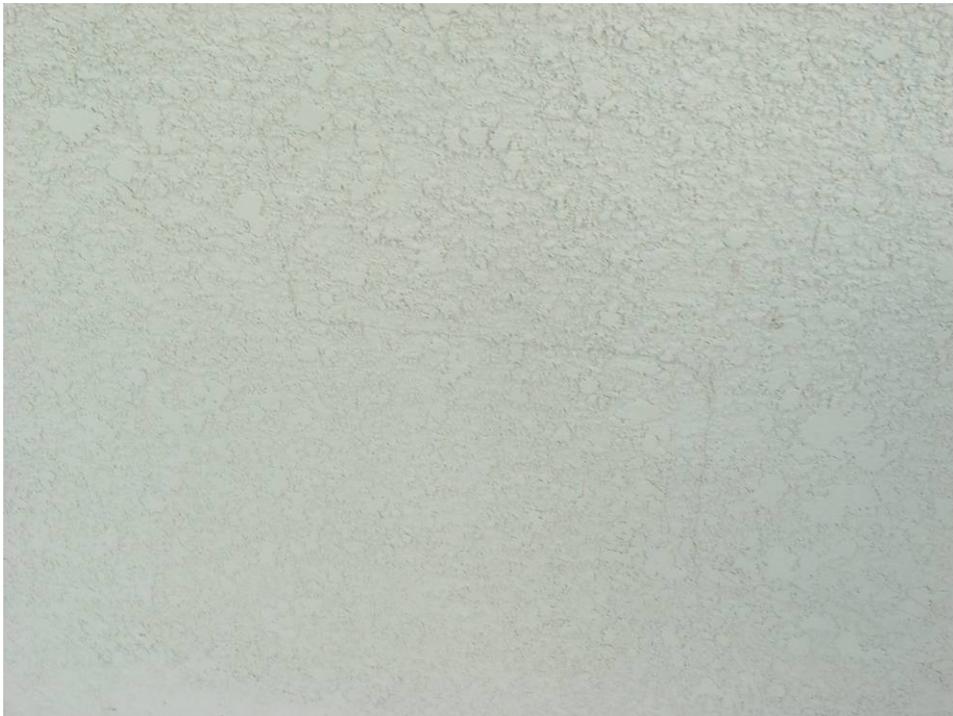
Figure 34 Typical staircase crack less than 0.39mm (1/64 inch) wide

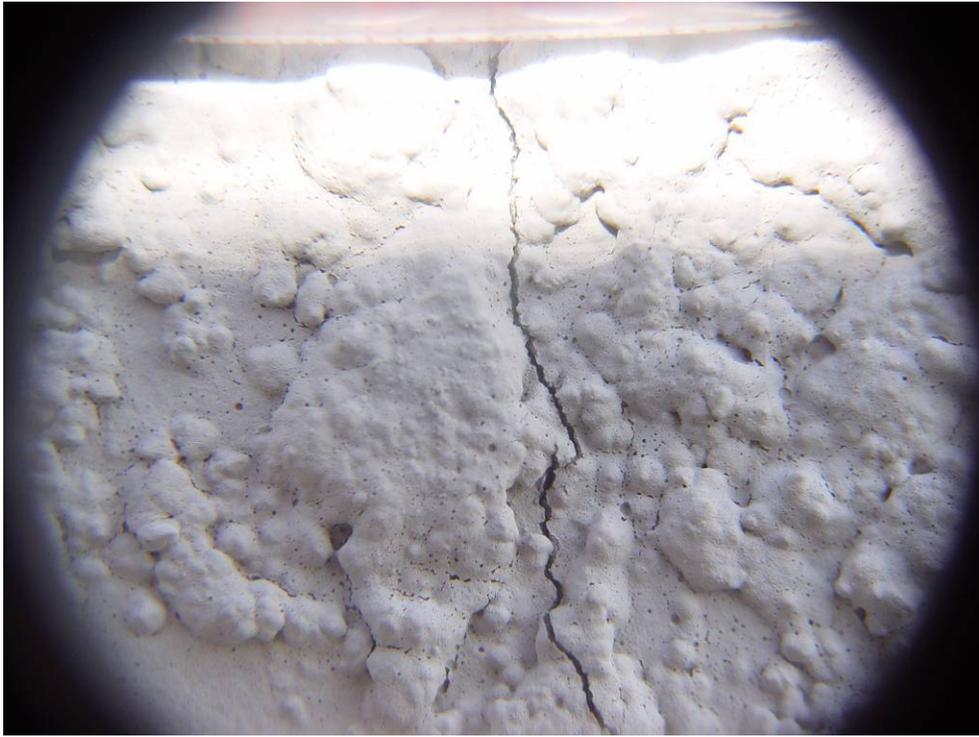
Figure 35 Typical crack between 0.39mm (1/64 inch) and 0.58mm (1/48 inch) wide

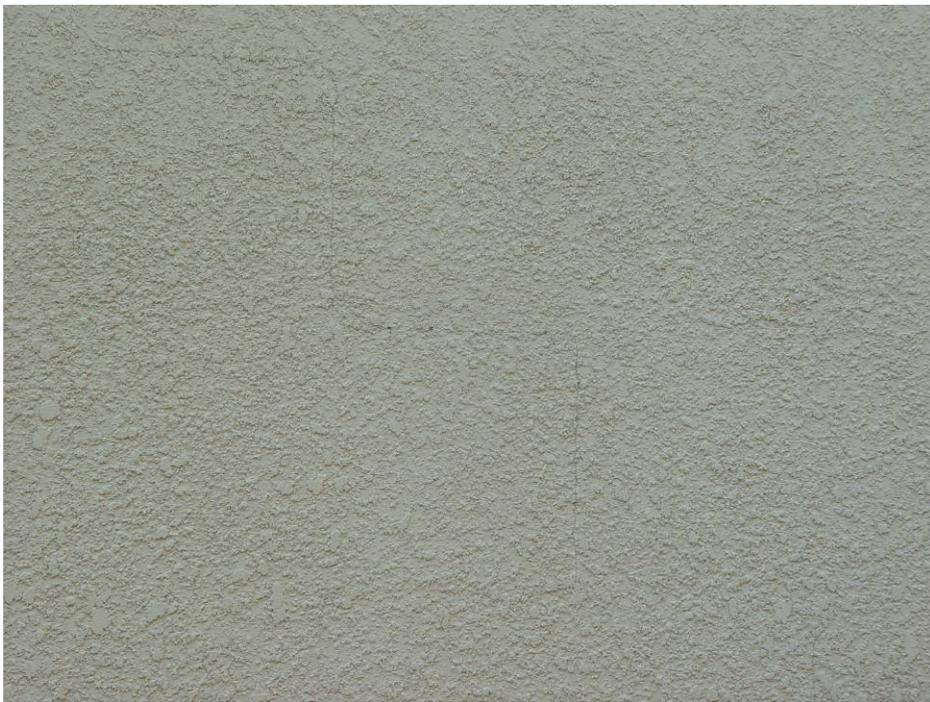
Figure 36 Typical stairstep crack between 0.39mm (1/64 inch) and 0.58mm (1/48 inch) wide

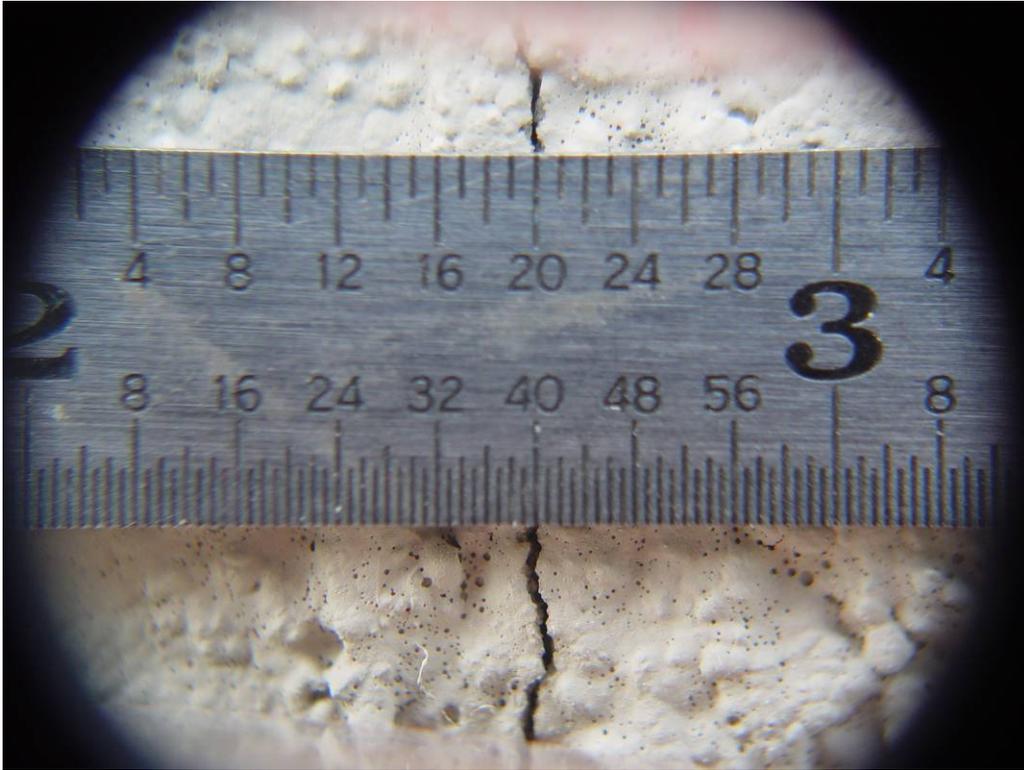
Figure 37 Typical crack between 0.58mm (1/48 inch) and 0.78 (1/32 inch) wide

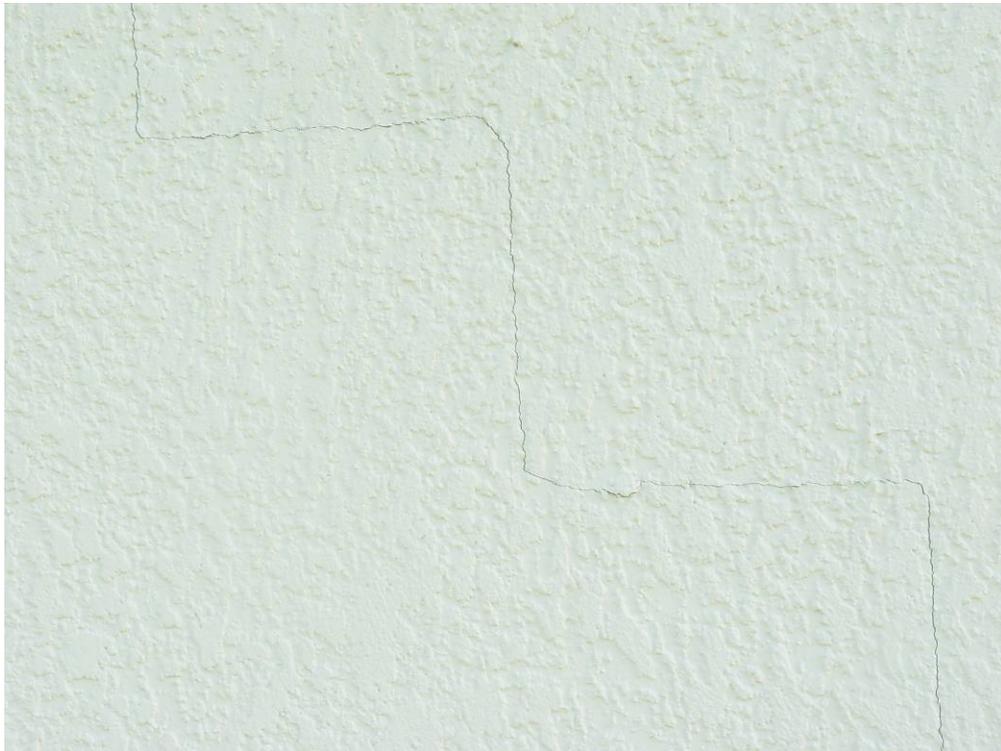
Figure 38 Typical stairstep crack greater than 0.78 mm (1/32 inch) wide

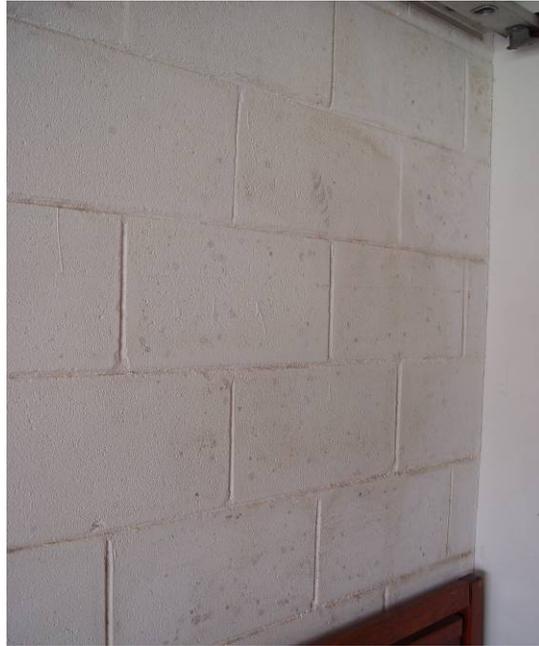
Figure 48 Discoloration in garage from water intrusion during storm

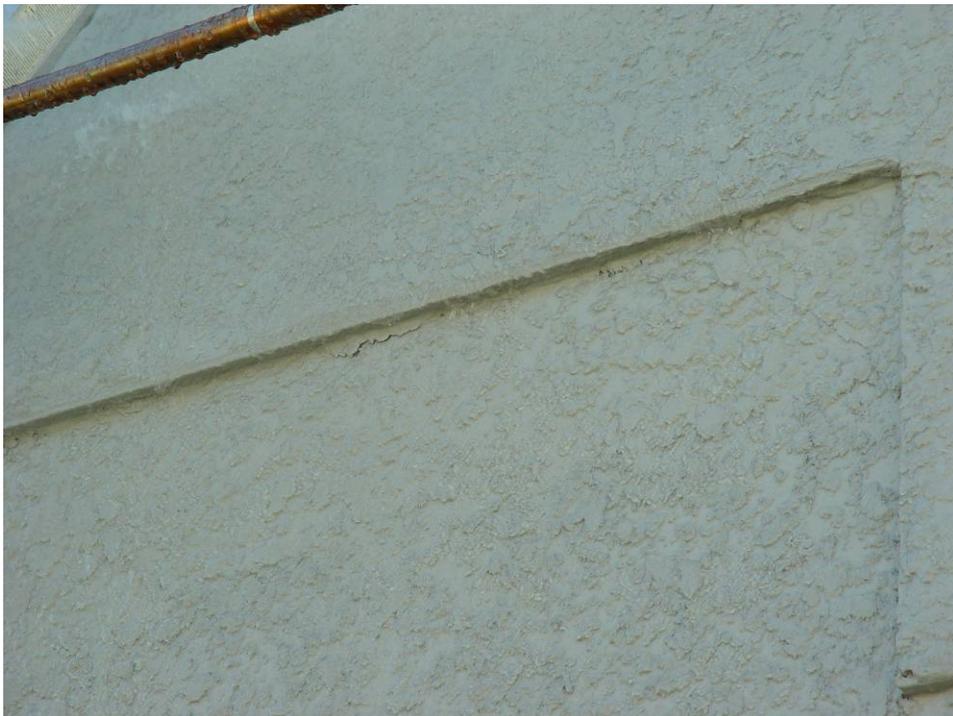
Figure 49 Minor cracking under expansion joint

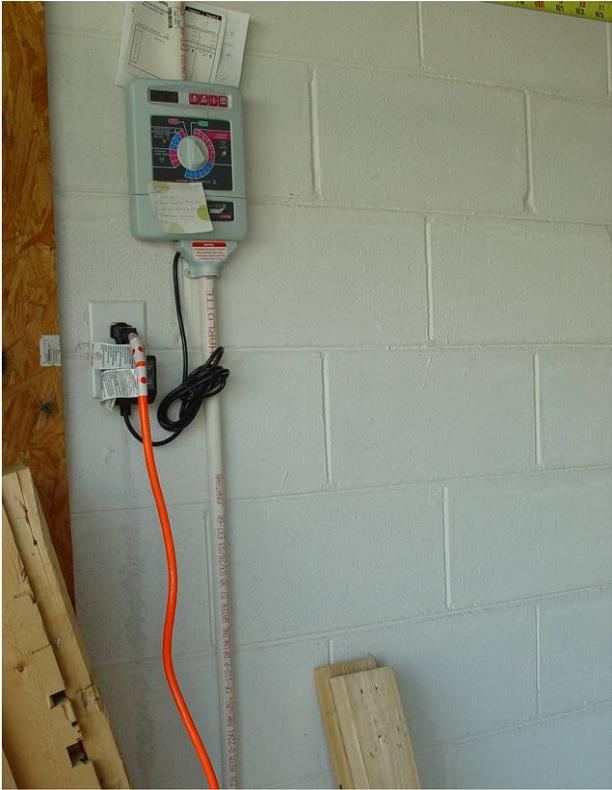
Figure 51 Note leak out of electrical outlet (directly under rain gauge penetration)

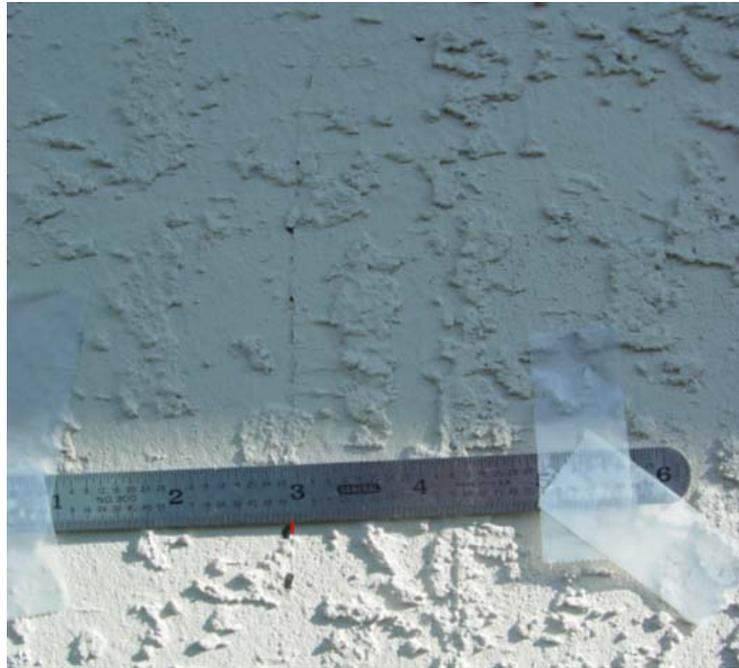
Figure 52 Home #2 with smallest crack measured (0.13mm wide) – testing revealed no intrusion

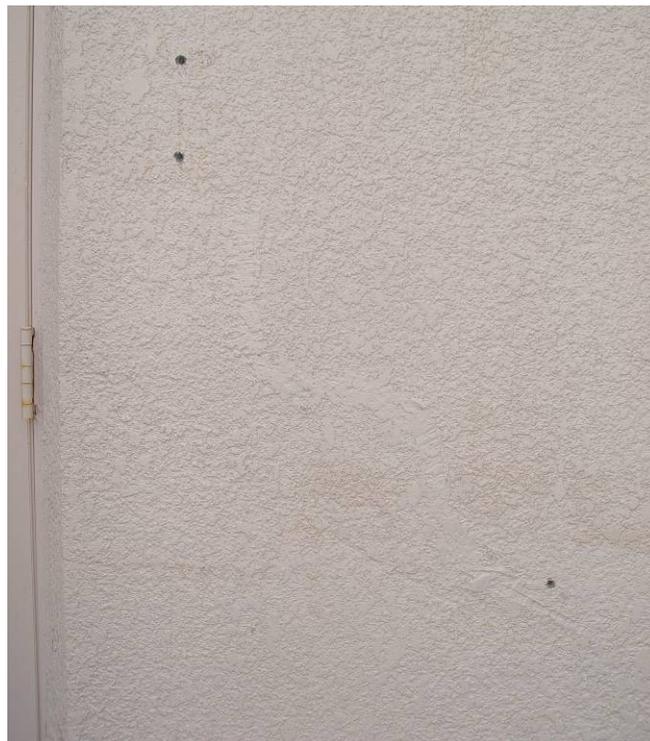
Figure 53 Home #3 test wall with stairstep crack that had been repaired

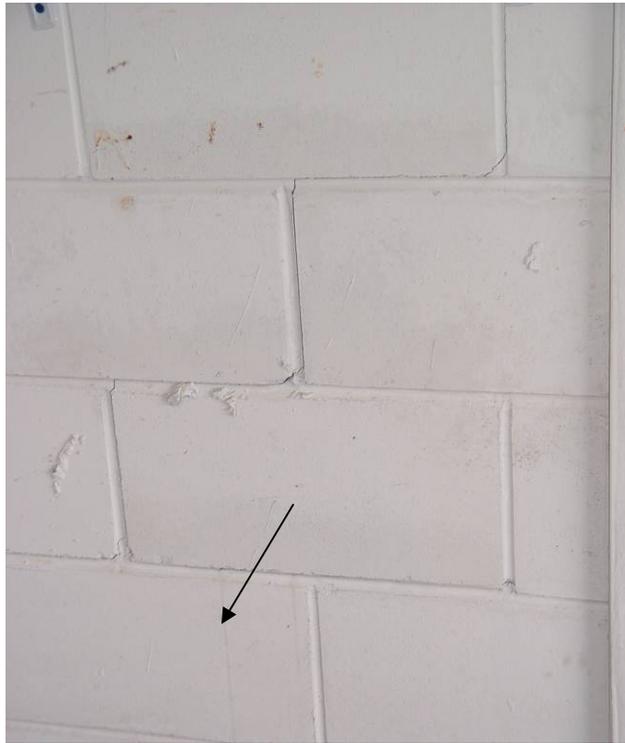
quarter hours into the test, water droplets started to form and run from the same level as the crack (Figure 54).

Figure 54 Home #3 showing through-wall staircase crack (not repaired on inside) and small water leakage out of crack (see arrow)

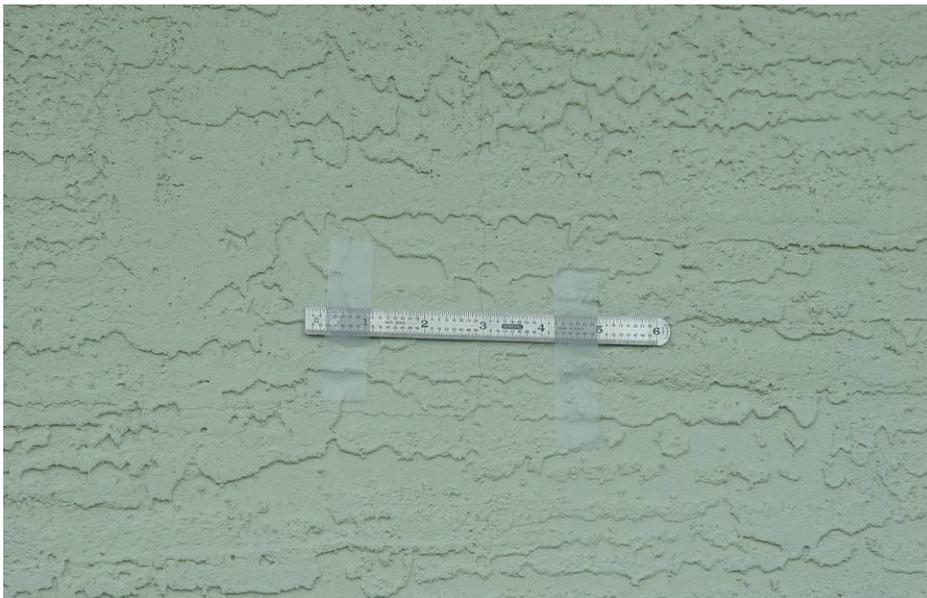
Figure 55 Home #4 showing staircase crack

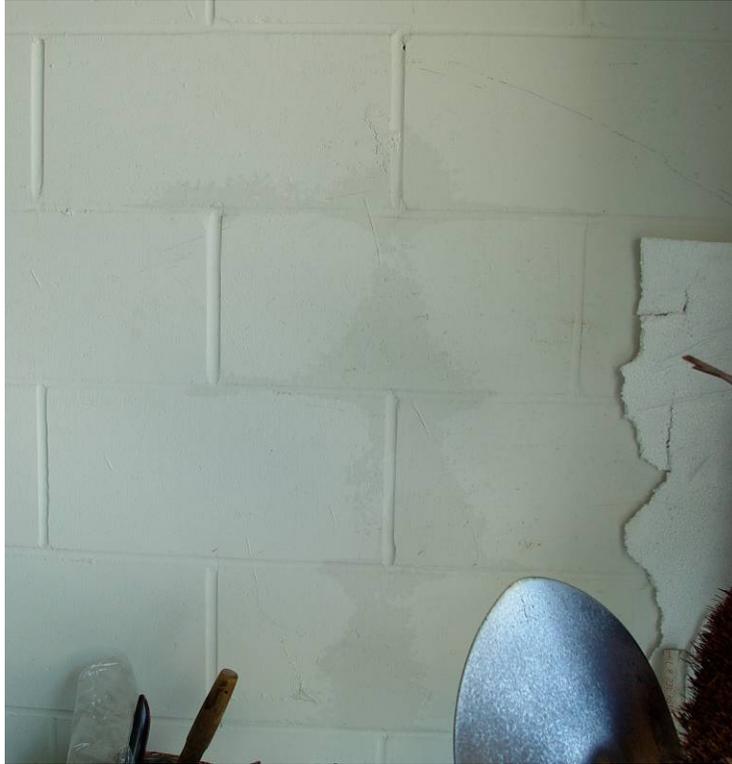
Figure 56 Home #4 showing through-wall stairstep crack and growing dampness

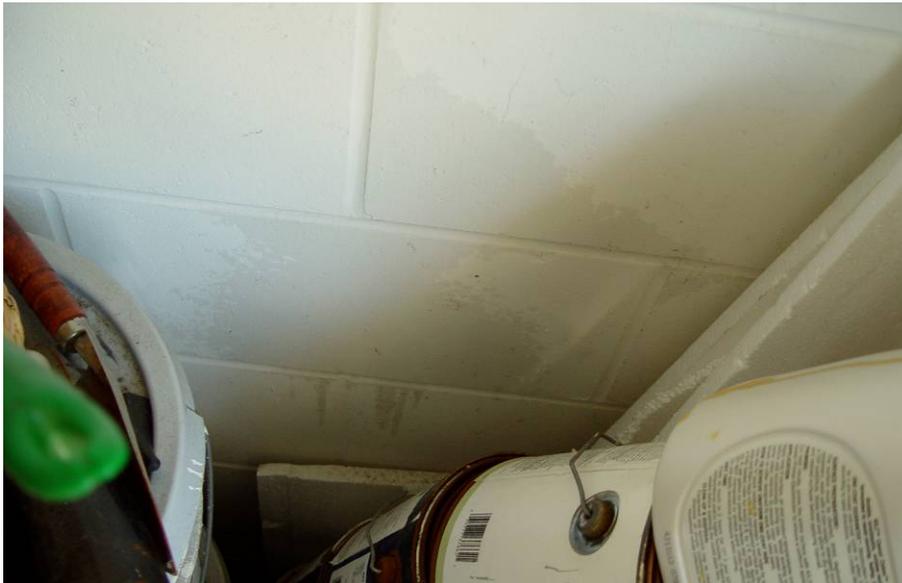
Figure 57 Home #4 growing dampness and drips forming near floor

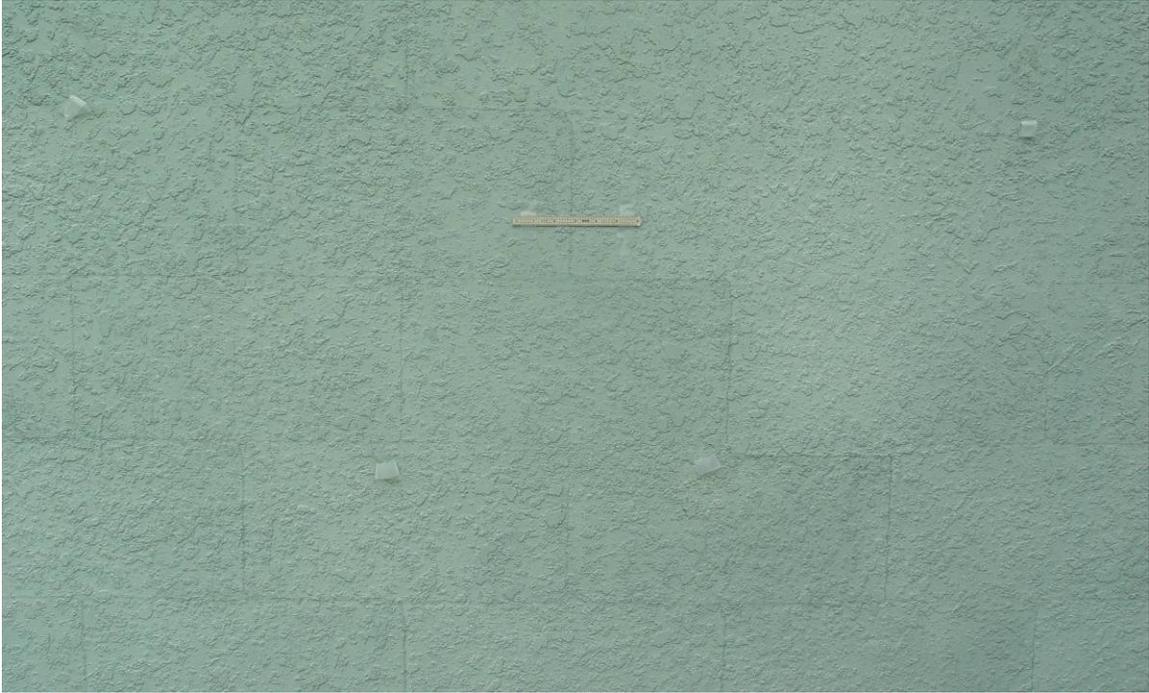
Figure 58 Home #5 showing stairstep cracks

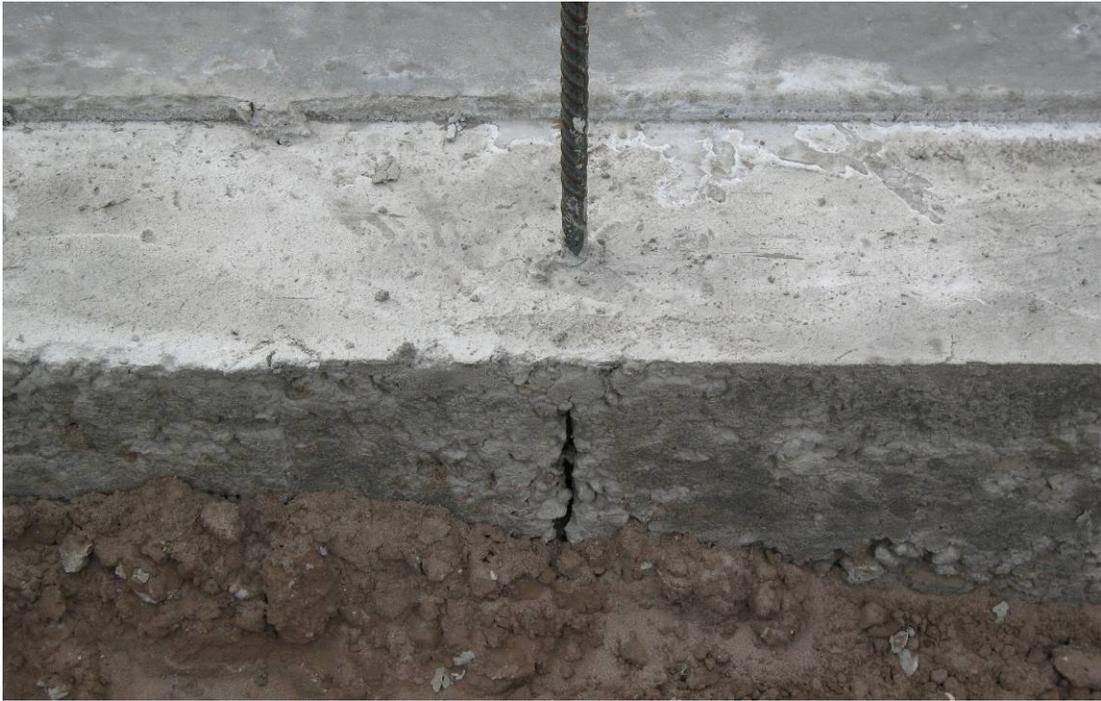
Figure 61 Incomplete concrete pour around vertical steel in foundation
