Water Intrusion in Central Florida Homes During Hurricane Jeanne in September 2004

Prepared by:
Dr. Mike Mullens, PE
Dr. Bob Hoekstra
Isabelina Nahmens
Felix Martinez

UCF Housing Constructability Lab

August 2006

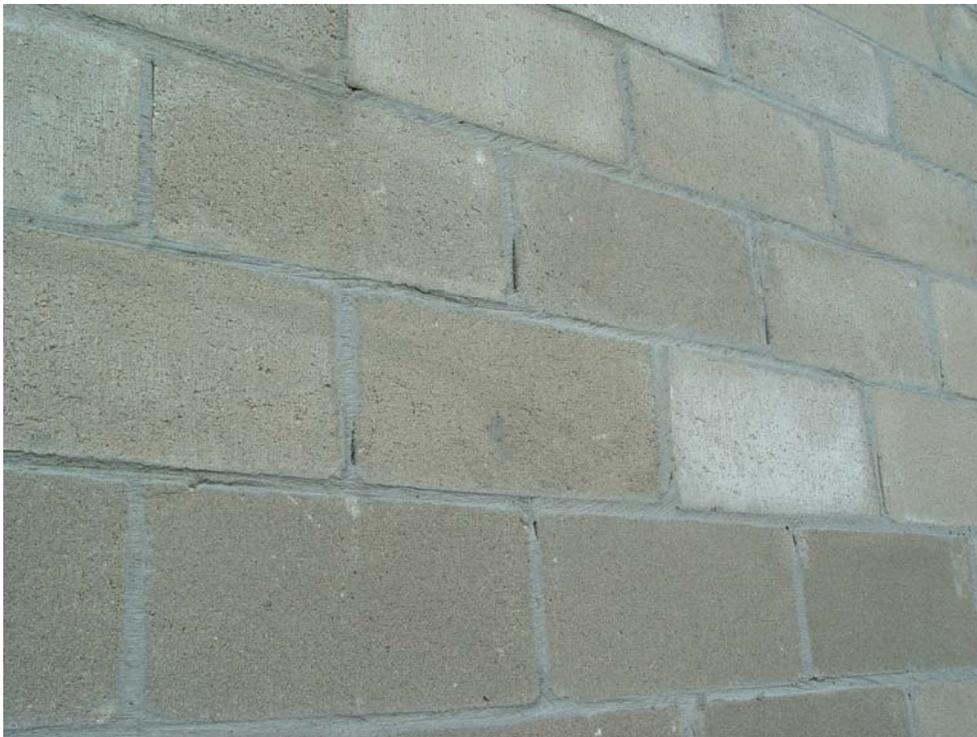
Figure 62 Typical cracks and voids observed in mortar joints in masonry walls

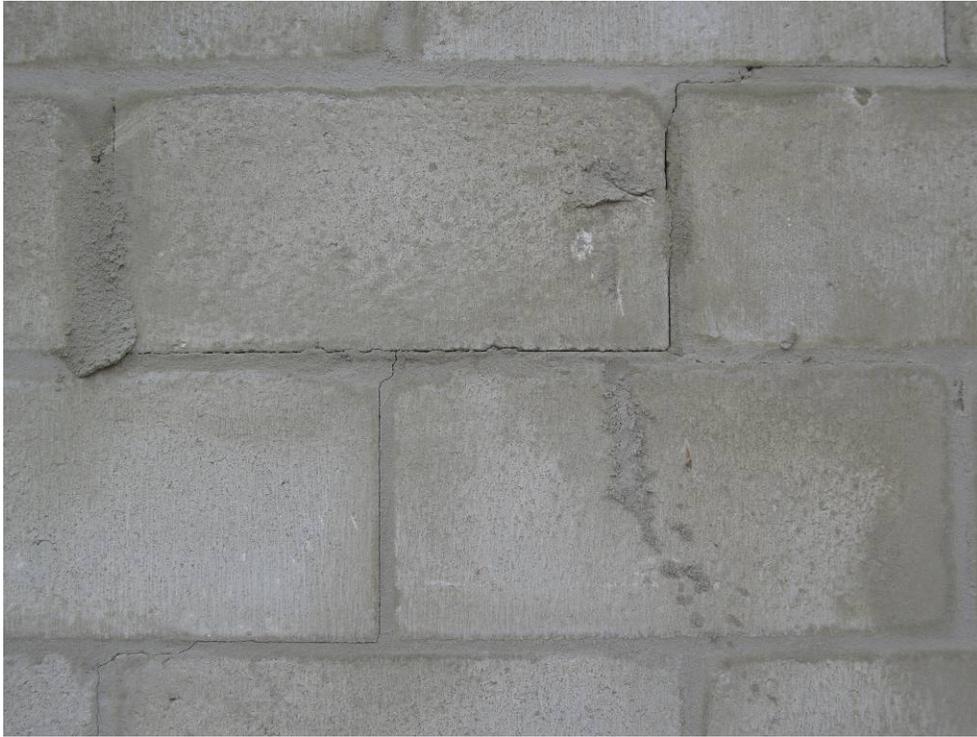
Figure 63 Extended stairstep crack on inside wall after grouting cells and installing roof

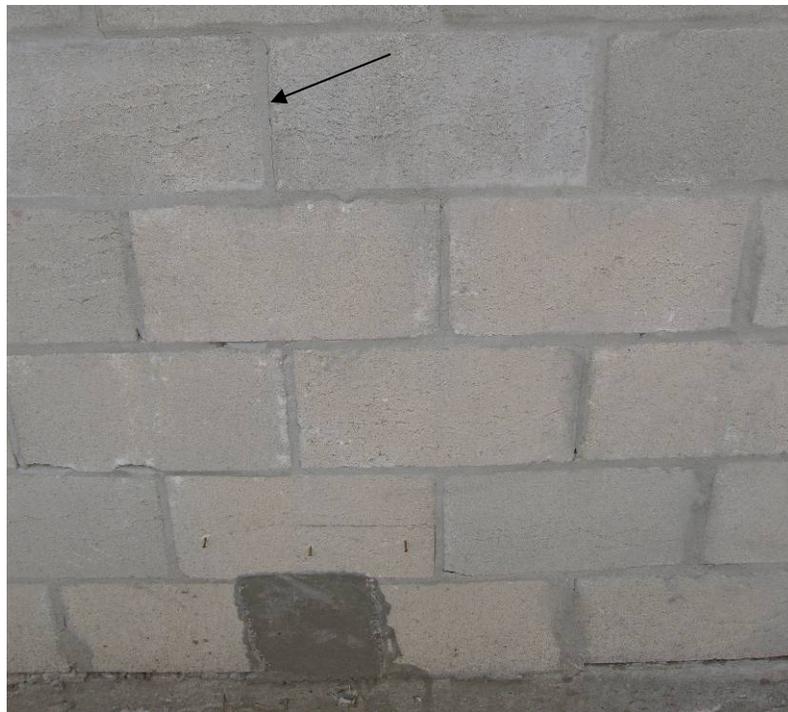
Figure 64 Extended stairstep crack (arrow) on outside wall after grouting cells and installing roof (note that crack extends through vertical grouted cell)

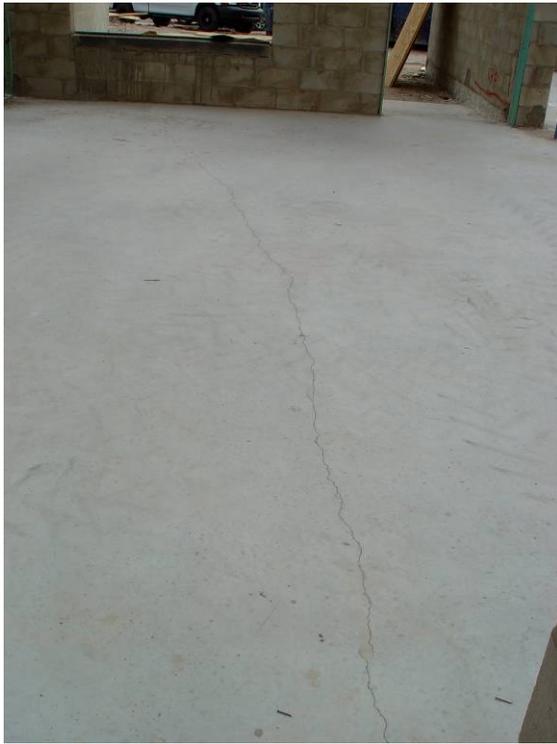
Figure 65 Typical crack in floor slab
