# Forum on Moisture Problems in HUD Code homes in hot, humid climates

## Case Study

## Just outside Kinder, Louisiana

By Neil Moyer-Principal Research Engineer

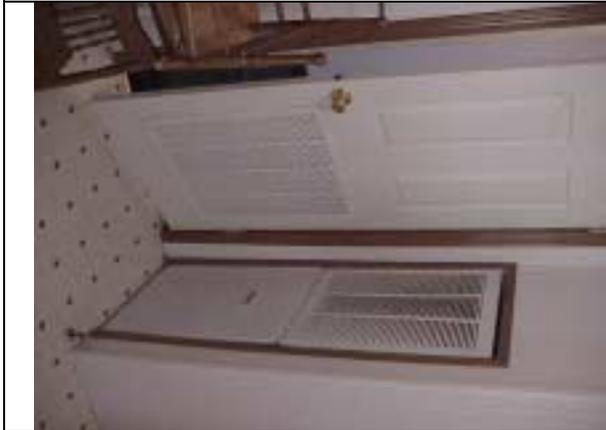
The air conditioner system is a 4-ton. The general condition of filters and coils appeared to be good. The condensate drainpipe from the air handler unit ends in the crawlspace below the air handler unit. It dumps the water onto the ground. The air handler unit is located in the utility room. This room acts as a return plenum when the door is closed (there is a grille in the door to allow passage of air).

View of AHU in utility room

- The negative pressure that exists in the utility room when the utility room door is closed should be reduced to as close to a neutral pressure as possible. Adding additional return air pathways to the utility room can do this. Pathways for return air can include a combination of strategies; removal of the utility room door, increasing the free air area of the current return air grille, adding additional through the wall returns or hard ducting the return air from the air handler unit to the hallway.

- The condensate drain line from the air handler unit needs to be redirected to deposit the condensate to the outside, away from the crawlspace.

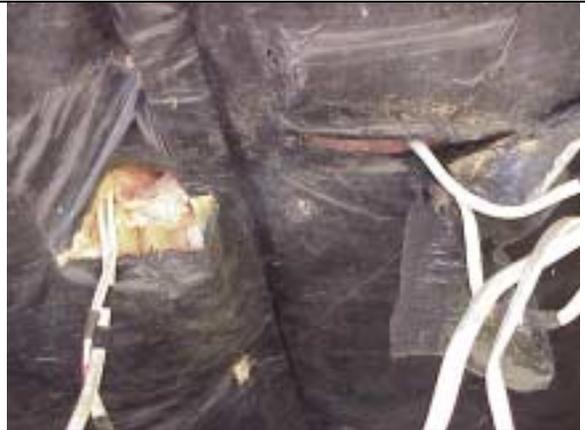
- The supply side duct leakage is significant. The operation of the air handler fan causes the house to operate in a negative pressure. This is because the supply leaks dump the air into the belly pan, which leaks to the crawlspace through various holes and penetrations such as those created by electrical and piping.
- The negative pressure that exists in the building when the air handler fan operates pulls attic air into the space via various penetrations that exist in the marriage wall. The trim pieces tend to direct the airflow along the flat planes of the ceiling and walls (as noted by the patterns of

Electrical penetrations in crawlspace

- All supply duct system leaks should be air sealed with a mastic (such as RCD#6 or equivalent). The seal must be applied to the air barrier of the duct. The areas that should be addressed include the supply register under the master bathroom vanity and all connections of the supply duct to the floor registers.

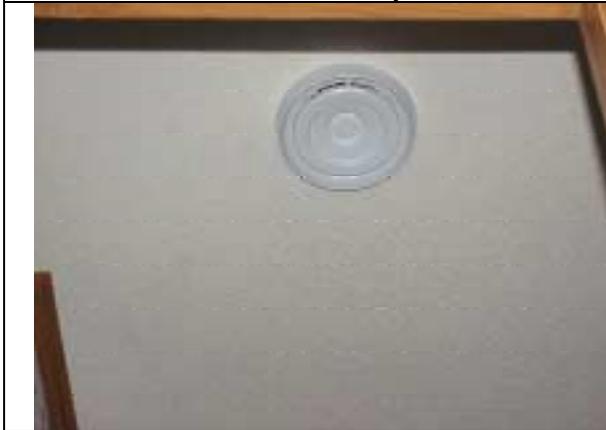
- The ventilation system used in this home is an exhaust only type. This will cause a depressurization of the home which will cause outside and attic air to be drawn into the space. This type of ventilation system should not be used in a hot, humid climate as a general rule. The best approach would be to install a positive pressure ventilation system that preconditions the air prior to entering the conditioned space. This preconditioning would include filtration, temperature adjustment and moisture removal.

Ventilation fan (utility room and msbath)

- A low cost alternative would be to install a fresh air duct to the return side of the air handler unit. When the air handler operates, outside air would be drawn into the air handler where filtration, cooling and dehumidification would occur. [This type of positive ventilation system works marginally in the hot and humid climate. The problem is that a conventional cooling system is not designed to handle much of a latent loading (dehumidification).]

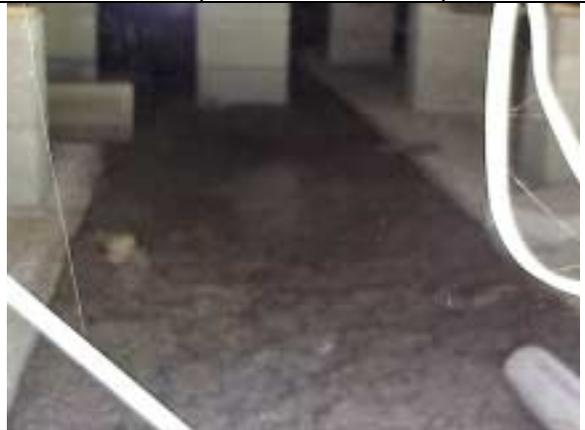
The house is a doublewide home. This is a 4-bedroom 2-bath dwelling enclosing approximately 1800 square feet of living space. The crawlspace skirting is not continuous, but open on either end below the marriage wall. There is not a ground cover laid down underneath the home. The major axis of the roof lays in an east-west direction that places the smallest exposed wall area to the greatest sunloading. Heating and cooling is accomplished with a centralized forced air system. A single air handler unit is located in the utility room. The duct system is located under the floor and is what is referred to as a perimeter system. The air conditioning compressor is located on the west side of the building near the rear bedrooms. A manually controlled exhaust fan in the utility room ceiling provides ventilation.

Crawlspace under west end bedrooms

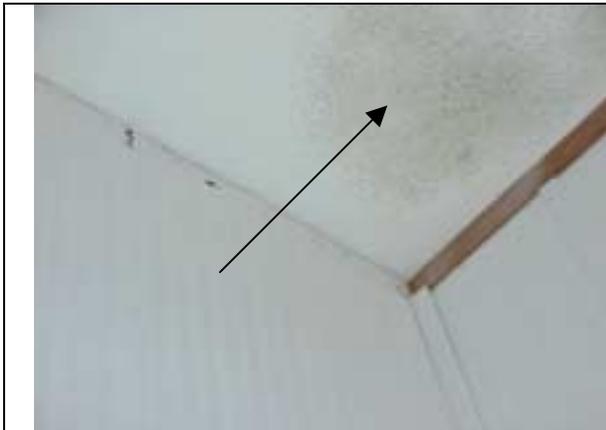
- The closet spaces with closed doors will tend to have a higher relative humidity for two reasons. First, they are connected to the attic space via cracks along the marriage wall behind the trim. As the building operates in a slight negative pressure, hot humid attic air is pulled into the closet at a slow constant rate. Secondly, the closed space will not receive cooling and dehumidification as there is not much of a pathway for airflow between the closet and the adjoining conditioned rooms.

Center bedroom closet ceiling mold

- All damaged ceiling panels (center and southwest bedrooms) should be removed and replaced.
- All of the other areas that show mold/mildew growth should be mitigated. This will require that the

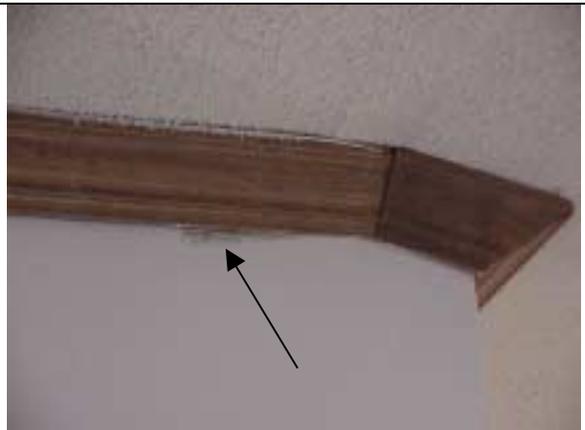
Staining of the ceiling area was noted in 5 areas, all where at or very near the marriage wall. This staining appears to be either dust/dirt markings, some type of biological growth or a combination of both. Generally, the areas of staining are relatively small (less than ½ square foot of area). The pattern of the staining appeared to be very similar to what would be caused by the movement of air passing from a hole and fanning out in all directions. The exceptions are the south and central bedroom closet ceilings, which appear to be entirely discolored. The ceilings are most probably contaminated with a mold / mildew growth.

Marriage wall kitchen-ctr bedroom mold

sources of airflow from the attic space along the marriage wall be eliminated. The mold/mildew areas should be cleaned or disinfected with a mildewcide or chorine beach solution.

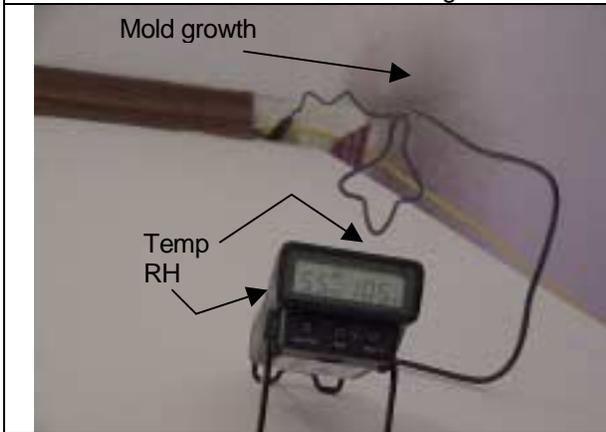
A temperature and relative humidity reading was taken at the ceiling marriage wall between the kitchen and dining room at about 1:30 in the afternoon. To get this reading, a piece of the trim was removed to place the probe in the area where it appeared that attic air might have been entering. The temperature of that air was 99degF and the relative humidity was 64%; this equates to a dewpoint temperature of about 85degF.

Temp - RH in marriage wall kit / dining

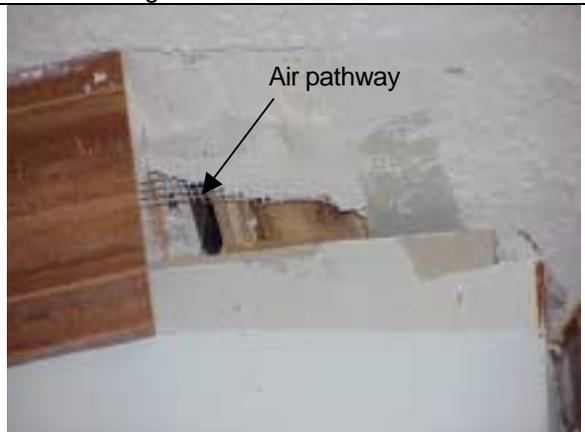
discoloration on the walls / ceiling). The entering air is at a very high dewpoint – above the temperature of the interior surfaces. The surfaces close to the entering point will tend to have a very high relative humidity, which promotes biological growth. The air entering will tend to carry small dust and dirt particles which will tend to discolor the surface and provide an additional nutrient base for the mold / mildew.

Marriage wall w/trim removed

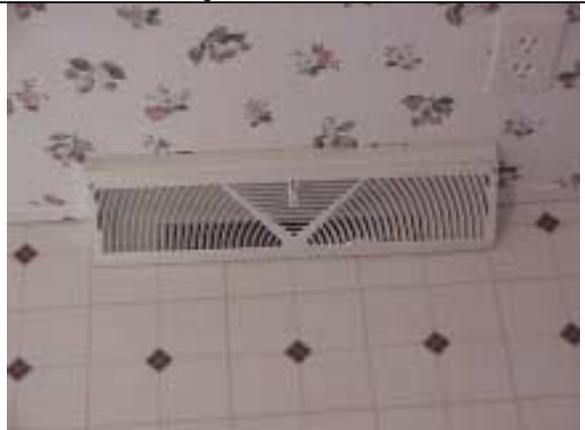
Typical floor register
