Habitat for Humanity of Brevard County, Florida: Existing Home Retrofit 1

This unoccupied, foreclosed, single-family detached home in Melbourne, Florida (Figures 1-2) was completed in 2011 by Habitat for Humanity of Brevard County, Inc.

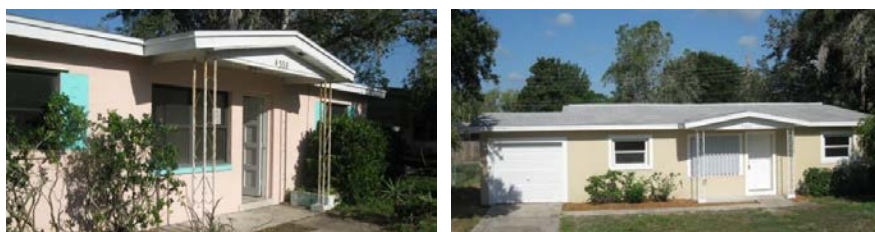
Figures 1-2. Pre-retrofit (left) and post-retrofit (right).

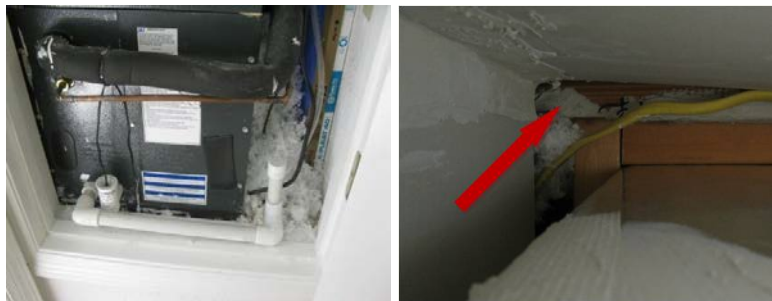
Working with limited air-handler closet space proved to be a challenge for the mechanical contractor. Unsealed holes in the ceiling of the air handler closet resulted in ceiling insulation to being pulled into the air handler closet when the mechanical system was running (Figures 3-4). Leaving a large hole in the closet is a result of poor quality assurance. Although researchers offered to retest the home, the partner declined post-corrective testing. The subcontractor returned to correct this installation.

Figures 3-4. White attic insulation around air handler (left) fell through spaces in the closet ceiling (right, looking up at closet ceiling framing).

Lack of quality assurance – The missing ceiling in the air handler closet points to a need for better quality assurance processes. Although the construction manager was aware of the need for this detail, it did not get integrated into the regular quality assurance procedures. Integrating new details into the existing framework of subcontractor communications remains a major challenge to achieving high performance in the retrofit arena.

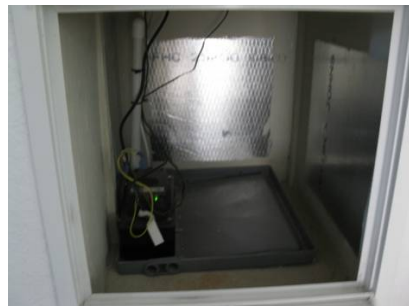
In contrast, the new return air plenum was notably well constructed by reversing the duct board (shiny side in) and sealing all seams well with mastic (Figure 5). This achieves an adequately sealed plenum; however, when researchers discussed this approach with engineering staff at one manufacturer and no known problems with this installation were in evidence; however, two concerns were raised. First, this approach is not consistent with manufacturer guidance on product use and therefore would likely not be supported in the case of a dispute involving the product in this configuration. Second, the foil side is a vapor flow retarder which should not be on the cold side of the assembly. This installation is inside the conditioned space so that the temperature and moisture conditions on both sides of the material are similar; however, if this were in an unconditioned space it would warrant a more thorough review.

Figure 5. New return air plenum constructed of foil faced duct board, shiny side facing in.
