Habitat for Humanity Palm Beach County, Florida: Existing Home Retrofit

***This case study is an excerpt of the following master report and has been modified to stand alone:**

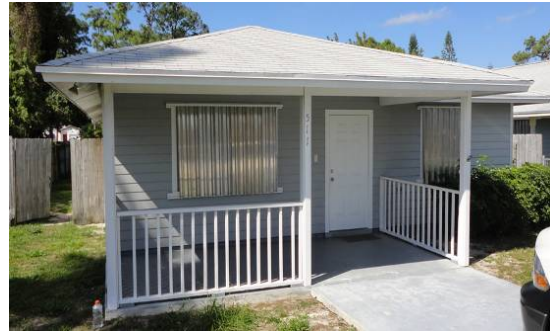
Figure 1. Pre-retrofit with hurricane shutters in place (exterior unchanged during retrofit).

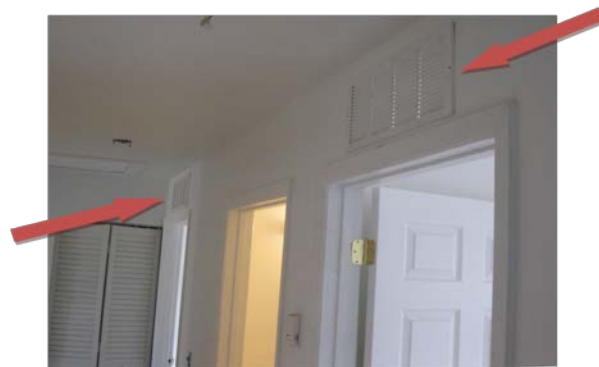
During the post-retrofit audit, pressure mapping was performed to assess whole house system pressure boundaries. Auditors induced a “worst case” scenario by running the air handler and exhaust fans and shutting all bedroom doors. Operating in “worst case” the home was only slightly depressurized (-0.5 Pa), and there was not excessive pressure built up in any of the bedrooms. Therefore, the existing above door transfer grilles are doing an adequate job of balancing mechanically induced house pressures. See Table 6 for a summary of the post-retrofit pressure mapping results. Figure 2 is a picture of above door transfer grilles.

Figure 2. Above door transfer grilles.

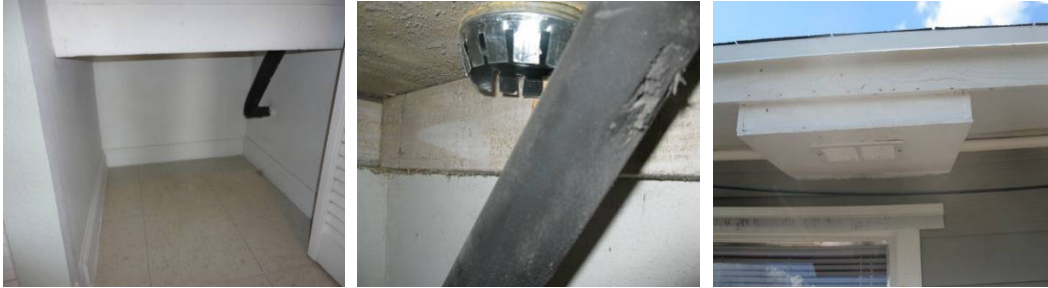
The slight increase in the whole house infiltration can likely be attributed to the installation of the passive runtime ventilation system into the return plenum, as there were no other penetrations into the envelope during the renovation. This passive run-time ventilation strategy also produces a slight positive pressure in the house with respect to the outside while the air handler is running, a building durability feature to ensure that infiltration of hot humid outdoor air will not occur under normal operating conditions and that any house depressurization will be neutralized with air from a known, clean path rather than through envelope infiltration points. Although auditors attempted to block the fresh air intake for the air tightness tests, duct mask did not adhere well to the boot or surrounding plywood.

The duct leakage-to-out was essentially unchanged between test-in and test-out; however, there was a worsening of the total duct leakage. The air handler and single, central return system were interior, with supply distribution running through the attic. With the house depressurized to -50 Pa, the attic registered at +47 Pa with reference to the main body of the house. This result indicated good separation between the conditioned space and the attic. Neither the mechanical system nor its duct work was replaced as part of this retrofit. Predictably, duct leakage to the outside ($Q_{n,out} = 0.05$) was essentially unchanged at test-out; however $Q_{n,total}$ increased from 0.09 to 0.12. Again, researchers attribute this finding to the outside air ventilation installation. Duct leakage test results are presented in Table 5.

Figures 3-5. Pre-retrofit return plenum (left), outside air ducted into the post-retrofit return plenum (middle), soffit retrofit for the air intake (right).

As noted earlier, the existing mechanical system was determined to have several years of useful life and was not slated for replacement. The partner agreed to work with researchers, however, to bring fresh air into the home via the mechanical system. Our recommended passive, runtime ventilation strategy involves connecting duct work from the outside into the return plenum near the air handler where it is mixed with house air when the system is running. The outside air is drawn through an inlet mounted in the soffit. In this design, the outside air is being filtered at the entry to the air handler rather than at the soffit. We have found partners, in general, are reluctant to install filter back grilles in the soffit for the outside air. The filter-back component requires depth at the soffit to accommodate a manufactured or fabricated boot. For low pitch, there is not adequate vertical space to accommodate this component. Additionally, partners are skeptical that residents will replace an outside filter. The reasoning seems to be concern over general awareness of the filter in the long term as well as lack of availability of correct size filters from the retail outlets. Since the outside air must be filtered prior to crossing the cooling coil, the

configuration implemented in this house has been accepted. An insect screen however was provided at the intake. Figures 3-5 show images of this installation.

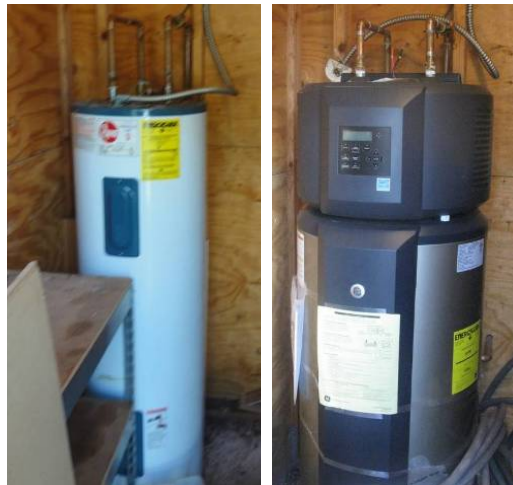
Figures 6-7. Pre-retrofit electric tank water heater, EF = 0.88 (left), hybrid heat pump water heater, COP = 2.35 (right).

The attached, unconditioned storage room measuring 7' x 8' x 9', was large enough to house a heat pump water heater. The installation of the hybrid water heater with heat pump (Figures 6-7) in this location has the added benefit of dehumidifying and cooling this storage area and the attic, which the room is open to.

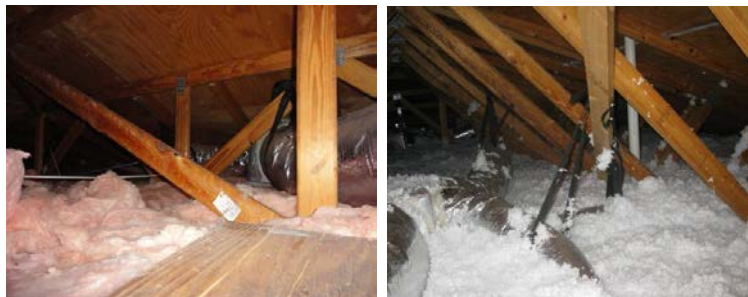
Figures 8-9. Pre-retrofit (left) and post-retrofit (right) ceiling insulation.

The existing ceiling insulation was comprised of R-19 fiberglass batts laid on top of the ceiling drywall. Blown-in fiberglass insulation was added to the existing batt, yielding R-38 total. Figures 8-9 illustrate the pre- and post-retrofit ceiling insulation.
