Habitat for Humanity of Brevard County, Florida: Existing Home Retrofit 2

***This case study is an excerpt of the following master report and has been modified to stand alone:**

**McIlvaine, J., Chasar, D., Beal, D., Sutherland, K., Parker, D., Abbott, K. (2012).
Partnership for High Performance Housing Draft Final Report. FSEC-CR-1911-12.
Florida Solar Energy Center: Cocoa, FL.**

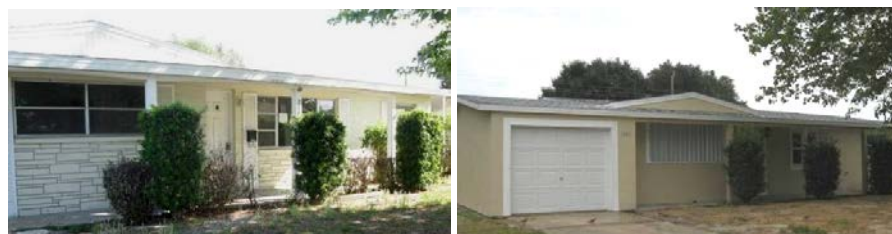
This unoccupied, foreclosed, single-family detached home in Melbourne, Florida (Figures 1-2) was initiated in 2011 by Habitat for Humanity of Brevard County,

Figures 1-2. Pre-retrofit (left) and post-retrofit (right).

The retrofit was completed on August 13, 2011. Measures with the most significant contribution to projected energy cost savings were the almost exclusive use of compact fluorescent lighting bulbs (CFLs), the installation of low-E windows, the reduction in house and duct leakage, and the installation of R-38 ceiling insulation, respectively. The entire package of improvements, listed in Table 2, is estimated to produce \$731 in annual energy cost savings. The partner has reported the costs for all of these measures to be \$7,867. Based on these costs, projected savings outweigh the added mortgage cost by an average of \$8 per month for an 11-year simple payback. Researchers also analyzed the incremental first costs for the higher efficiency options. Considering only incremental costs, monthly cash flow is increased to \$38, and simple payback is reduced to 5 years.

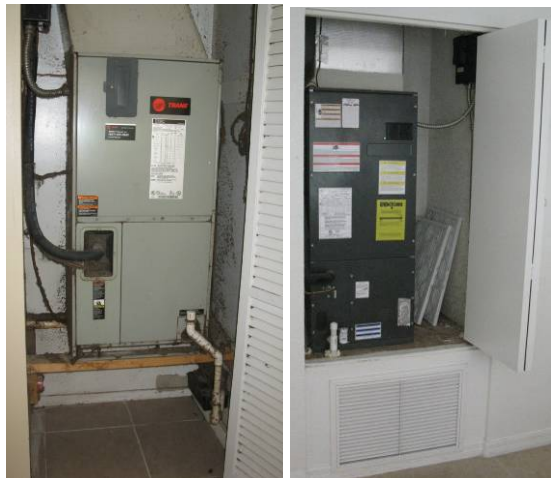
As previously mentioned, the existing mechanical closet was poorly designed with an open return in a closet with airflow-restricting louvered doors. Such a design allowed for uncontrolled airflow and resulted in dust build-up. The mechanical system retrofit included constructing a ducted return and bringing filter access to the wall plane (Figures 3-4). Outside air ventilation via a runtime vent was not incorporated into this mechanical system retrofit. Although the deep retrofit package proposed to the partner recommended outside air, researchers prioritized efficiency measures at this early stage in the partnership. Post-retrofit duct leakage tests confirmed that the contractor performed a good job with respect to sealing the supply plenum and return plenum. If post-retrofit whole house air tightness testing had revealed an extremely tight envelope, researchers would have re-visited the issue with the partner.

Figures 3-4. Air Handler Closet: Pre-retrofit without return plenum and installed behind airflow-restricting louvered doors (left), Post-retrofit platform return plenum with filter access on same plane as wall (right).

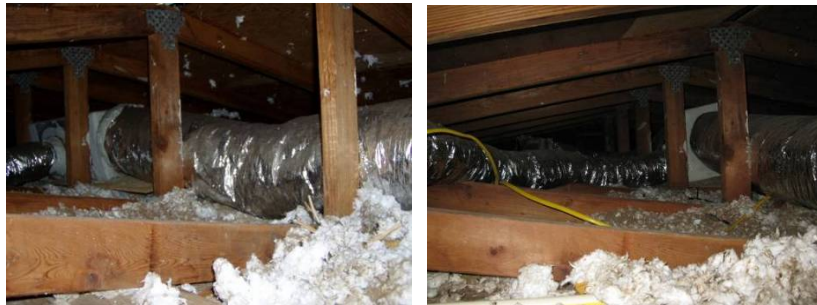
During the test-out audit, researchers observed no change in the attic insulation, which was previously estimated to be an average of R-11 (Figures 5-6). Our partner understood the insulation contractor had completed this work before scheduling our post-retrofit audit. Ultimately, fiberglass was blown-in to achieve R-38. However, this measure would have potentially been skipped had it not been for our involvement in this retrofit.

Figures 5-6. Ceiling insulation: Pre-retrofit estimated average of R-11 (left), post-retrofit no additional insulation (right).

The partner failed to confirm the completion of all subcontractor work. This lapse in communication and lack of central oversight indicate a gap in the contracting paradigm.
