## Using thermography to reduce residential energy use

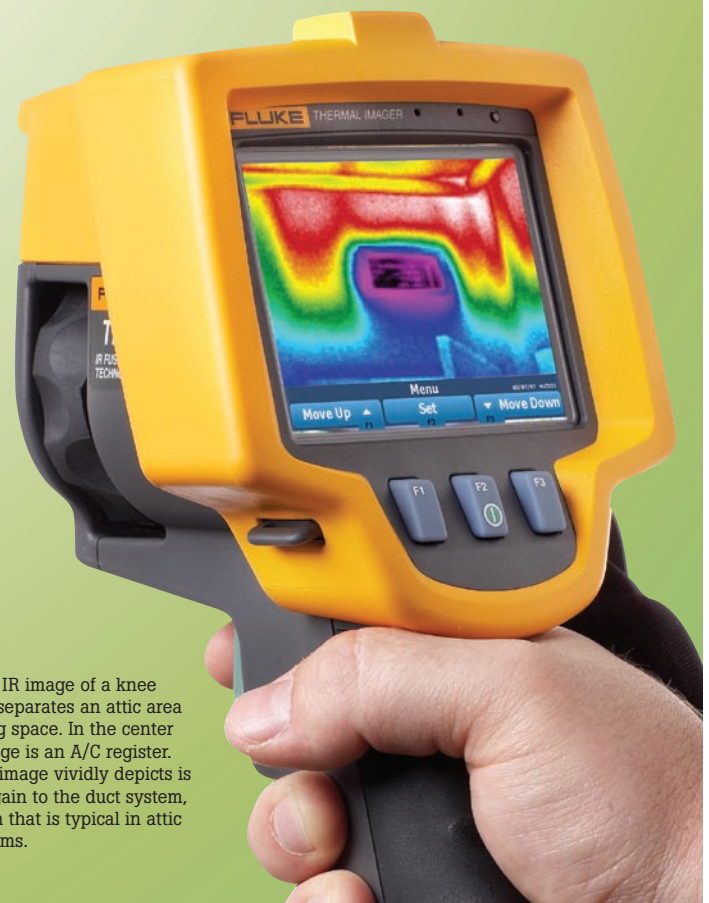
This is an IR image of a knee wall that separates an attic area from living space. In the center of the image is an A/C register. What the image vividly depicts is the heat gain to the duct system, a situation that is typical in attic duct systems.

Parker reveals that FSEC's researchers have for some time been computing what the impact of this practice is. It is, to use his word, "deleterious." He says that having a duct system in the attic means a loss of 25 percent to 30 percent of a cooling system's potential during the hottest part of the day in the summer. "You're cooling the air inside the house and then introducing it to the attic," Parker notes. "There it warms up before it feeds through ceiling registers."

To illustrate his point, Parker refers the reader to the accompanying thermal image. Since attic duct sys-
