## Building America Case Study Efficient Solutions for Existing Homes

# Bay Ridge Gardens – Mixed Humid Affordable Multifamily Housing Deep Energy Retrofit

Annapolis, Maryland

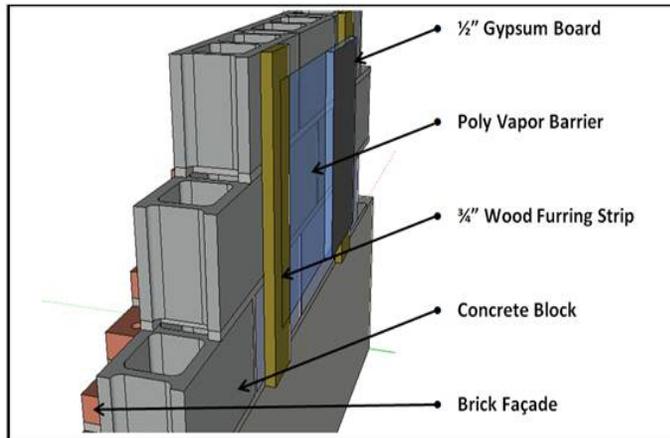
Exterior Wall Assembly

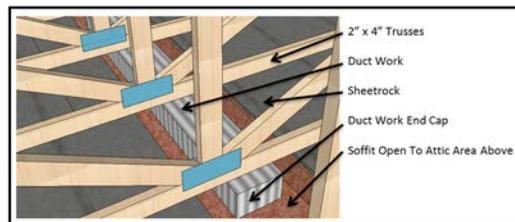
Diagram of bulkhead and duct trunk line open to attic

- Hybrid Heat Pump: 8.50 HSPF, 92.5 AFUE 2-stage furnace backup; 15 SEER, 1.5 ton air conditioning; resident pays for electricity and has incentive for reducing heating energy
- Aerosolized duct sealing for up to 63% reduction in total leakage
- Air sealing and insulating duct bulkhead which was exposed to the adjacent attic space above.
- Energy Recovery Ventilator for balanced, continuous ventilation and minimizing ventilation-induced airflow between apartments
