Case Study

# High Performance Residential Retrofits

Florida and Alabama

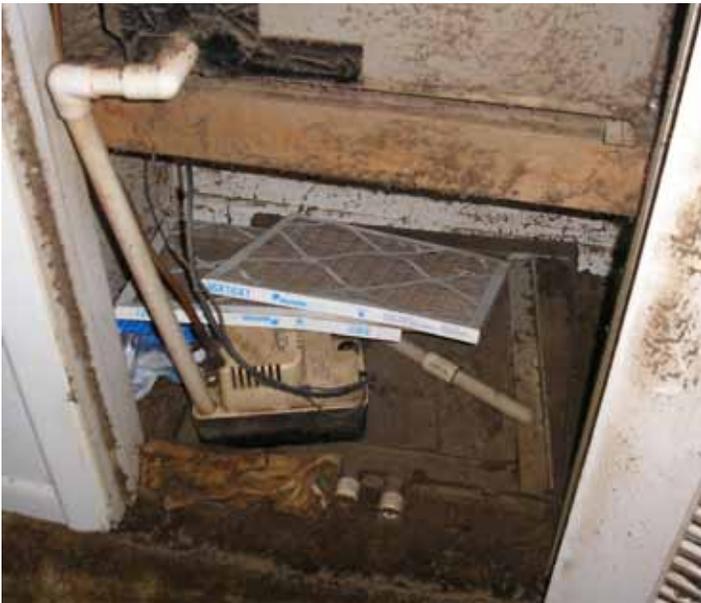
Mold and debris in air handler closet

Another stumbling block of the study is that partners are often slow to acquire properties as they are not able to contract to purchase as quickly as their competition. There have also been long delays in starting renovations as they work to get their programs in place. Many of the properties have been severely neglected and some vandalized. Because of these conditions, certain assumptions have been made about the as-found characteristics of the homes. Some have a potentially significant impact on the calculations of test-in whole house efficiency. For example, when a home has significant mold issues (see photo above), tests cannot be performed. Therefore, infiltration and duct leakage levels have to be estimated.

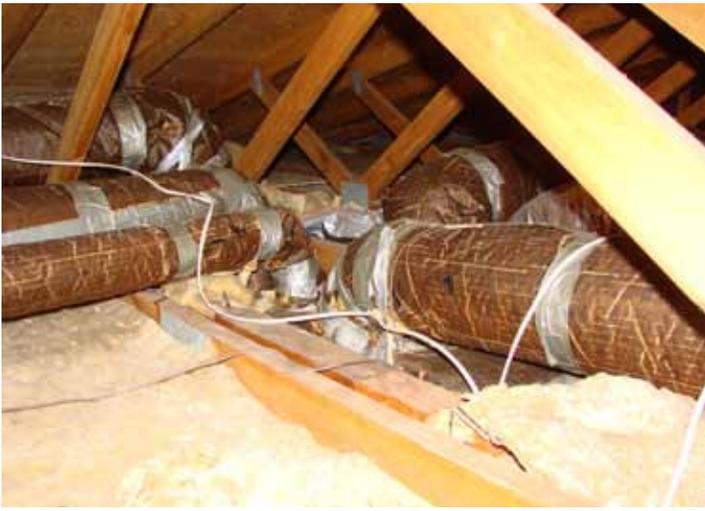
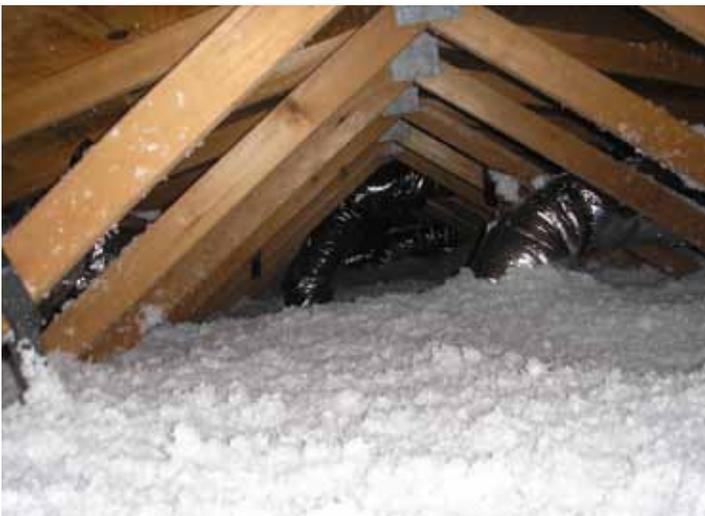
Typical attic insulation before (top) and after (bottom)

Typical envelope related findings include single pane case-ment windows with poor closure, low levels of attic insulation, and missing plumbing access covers and other drywall holes causing high levels of air infiltration. The homes typically have old or missing appliances and little, if any, fluorescent lighting, including compact fluorescent light bulbs (CFLs). Split-system forced air mechanical systems are the norm. Heat pump and electric resistance configurations are both common in the central Florida homes with gas heating dominating in north Florida and Alabama. All homes had a single central return, rather than a set of return ducts from each room. The test-in audits produced HERS Indices ranging from 92 to 184, with a mean of 130. A summary of the test-in HERS Indices broken down by decade is provided in Table 1.
